IMPACT ECHO (IE)

SYSTEM REFERENCE MANUAL 2008

IMPACT ECHO TEST NDE-360

NDE-360 Platform with WinTFS Software Version 2.3

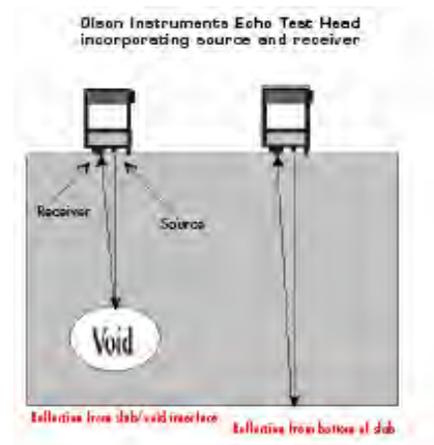
The IE tests involved impacting the concrete/masonry member with an impactor solenoid and identifying the reflected wave energy with a displacement transducer as shown in the figure below. Note that the solenoid impactor and a displacement transducer are built in the IE head. The test head was pressed against the top of the tested member and held while tests were performed at each test point. The resonant echoes of the displacement responses are usually not apparent in the time domain, but are more easily identified in the frequency domain. Consequently, amplitude spectra of the displacement responses are calculated by performing a Fast Fourier transform (FFT) analysis to determine the resonant echo peak(s). The relationship among the resonant echo depth frequency peak (f), the compression wave velocity (V_p) and the echo depth (D) is expressed in the following equation:

$$D = \beta V_p / (2 * f) \tag{1}$$

where β is a geometric shape factor equal to from 0.8 for a pier/column shape to 0.96 for a slab/wall shape. A slab/wall shape has a single thickness resonance while beam and column shapes have multiple resonances due to their cross-sectional shape.

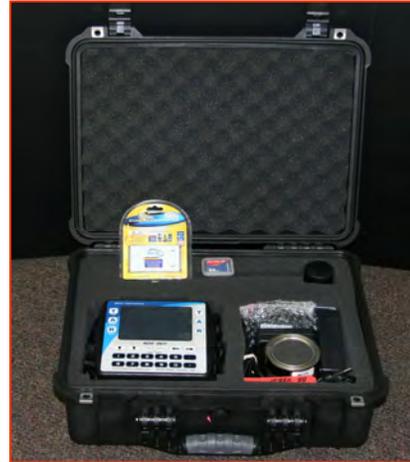
The IE system with the NDE-360 platform consists of several basic components packaged into a padded carrying case. The padded case stores the NDE-360 data acquisition platform, power supply, battery charger, accelerometer, hammer, grease, and cables. A description of each of these components as well as their connection and operation is included in the following sections.

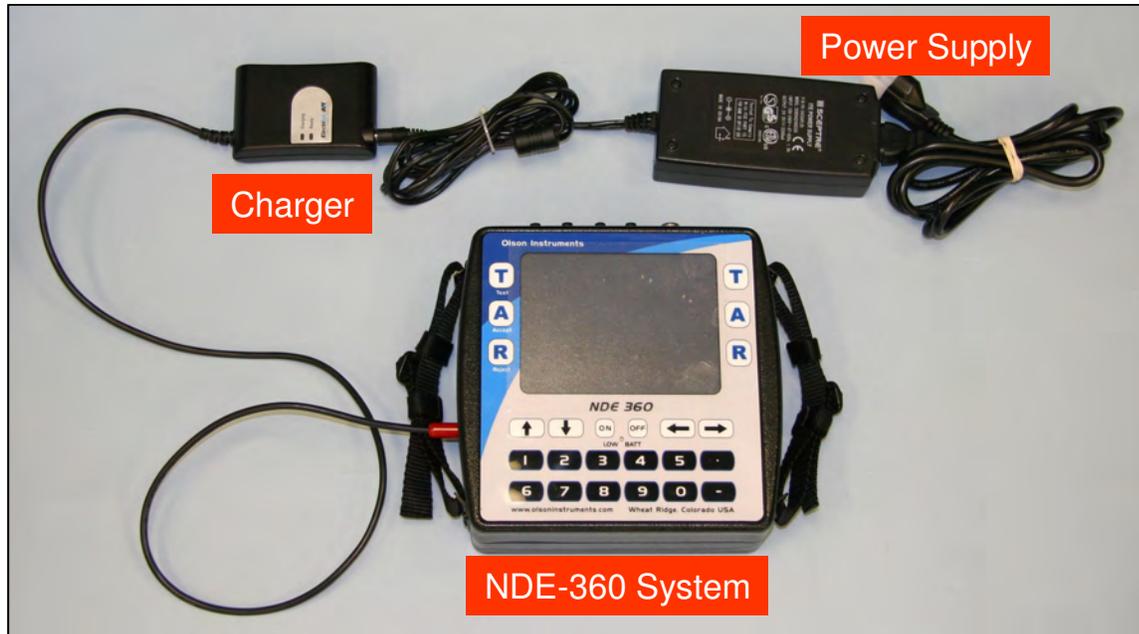
Battery Charging: The power supply (Item 4) must be plugged into the charger (Item 5) only. Then the charger (Item 5) must be connected to the NDE-360 system.

Time required for a fully charge of battery is 8 hours. Fully charged battery will power the NDE-360 system for 8 – 10 hours.

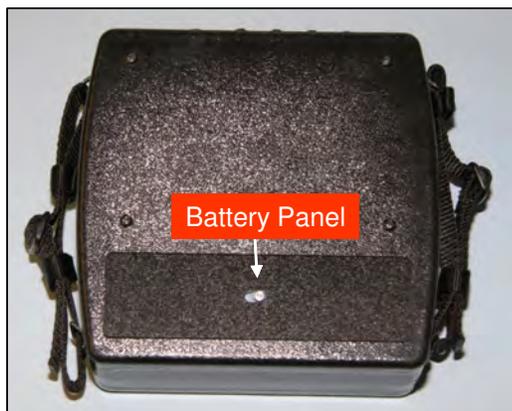
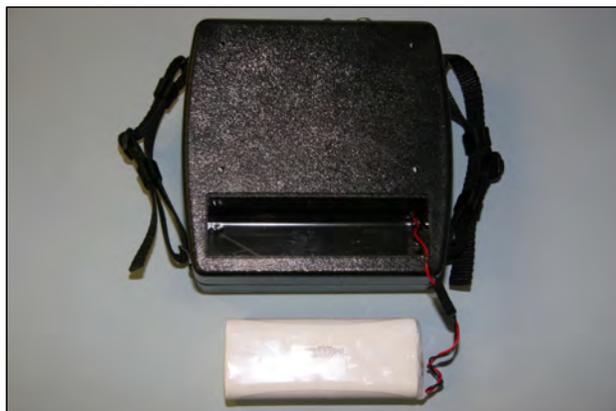
Location of Battery: The panel housing the battery is located on the back of the NDE-360 system. Move the switch to remove the battery cover if battery needs to be replaced.

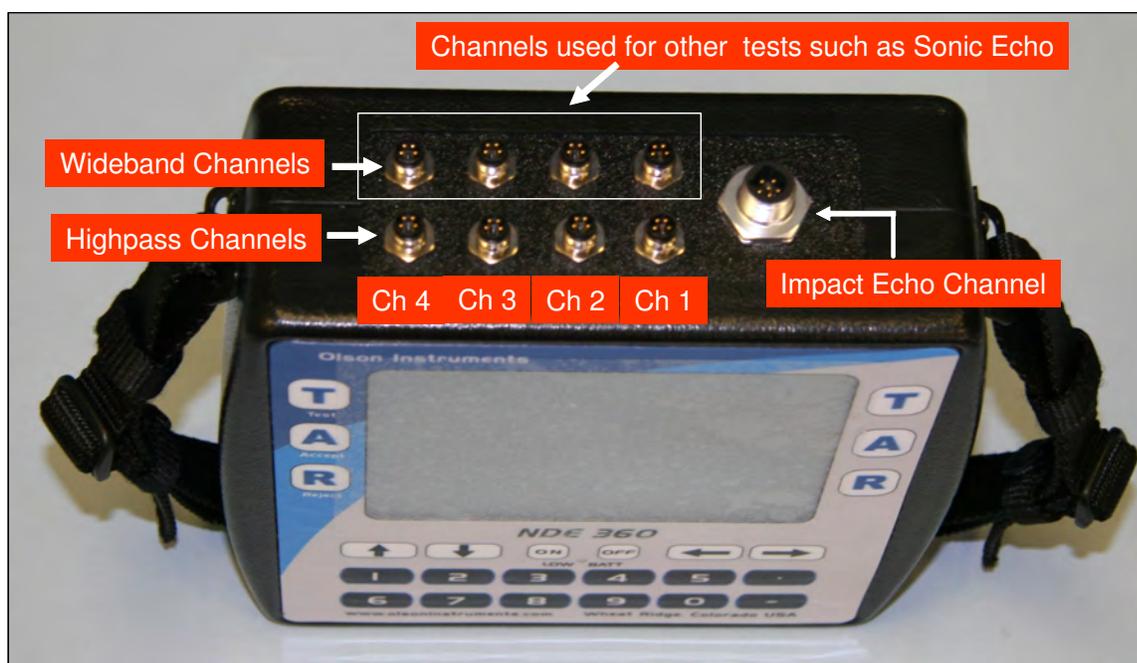
Channel Arrangement: The NDE-360 system is equipped with 4 channels. There are two 4 pin connectors per channel. Channel 1 is located on the right hand side if facing the front screen of the NDE-360 system. In this case, the IE test uses the Impact Echo Channel. Thus four 4 pins channel will not be used for the IE test.

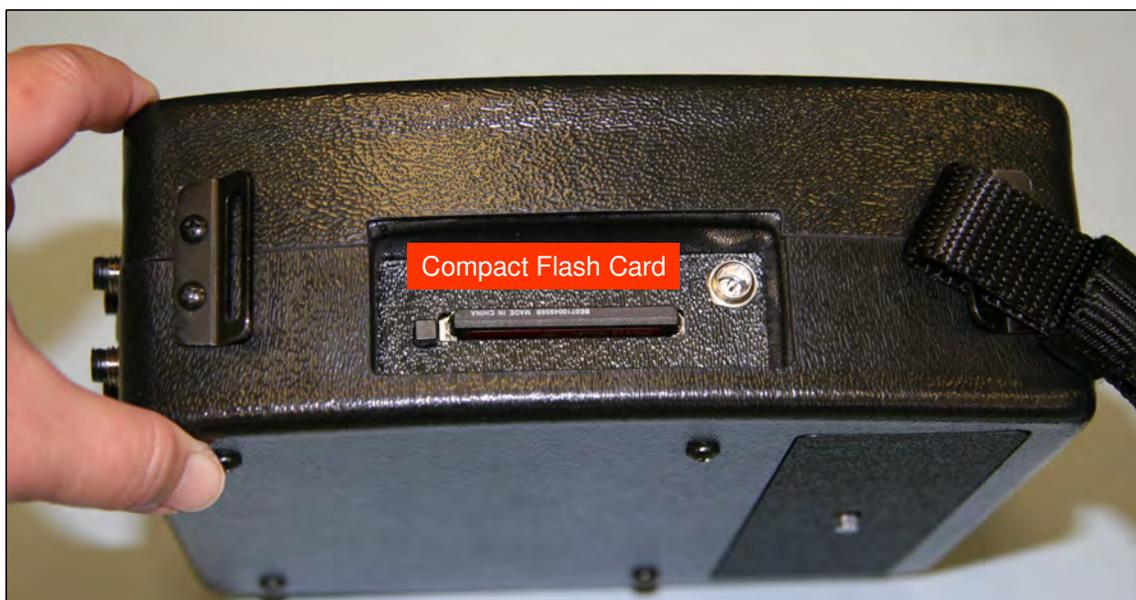
Data Storage: A compact flash card is used to store the IE data files. In addition, the master program controlling the IE test is stored in the compact flash card. The system must start up with the compact flash secured in place. The card should be located on the left side of the NDE-360 system if looking at the front screen.

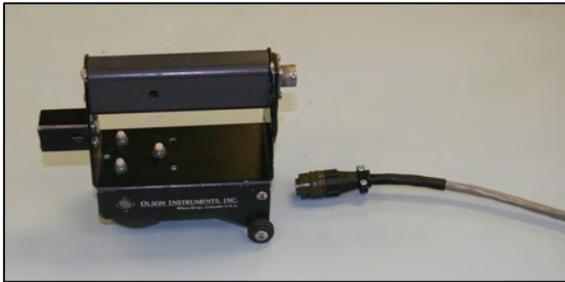
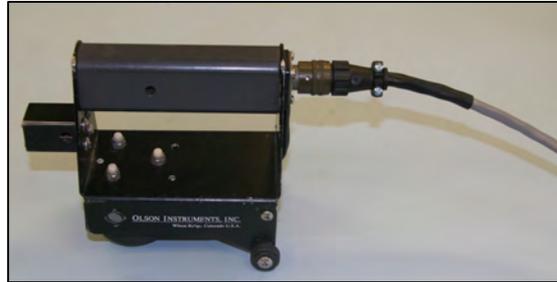
1. Connect the cable (Item 3) to the IE head (Item 2) by aligning the pin on the cable with the corresponding hole in the IE head

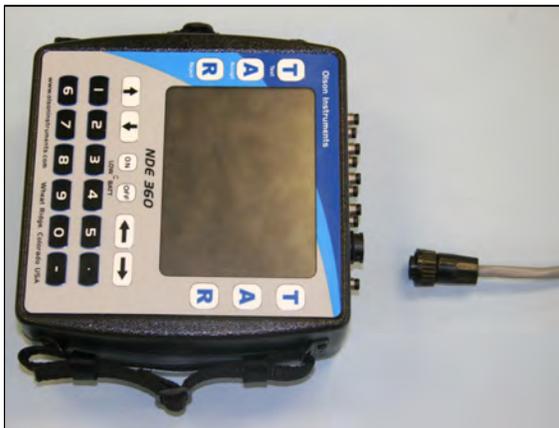
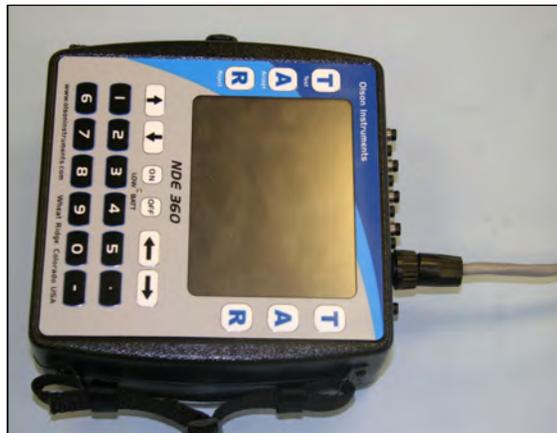
2. Connect the other end of the cable to the IE Channel on the NDE-360

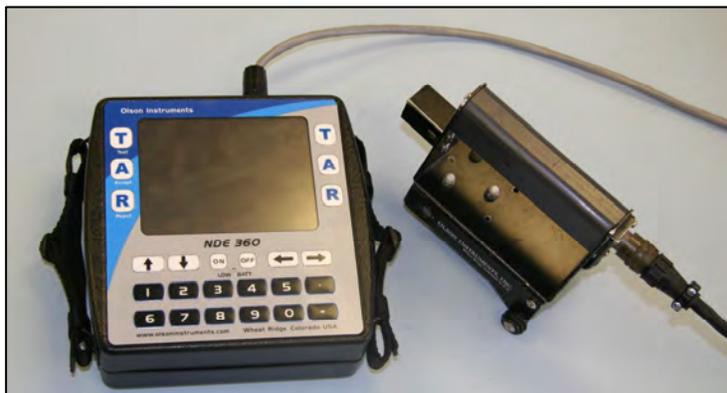
3. The picture below shows a complete hardware setup for the IE test.

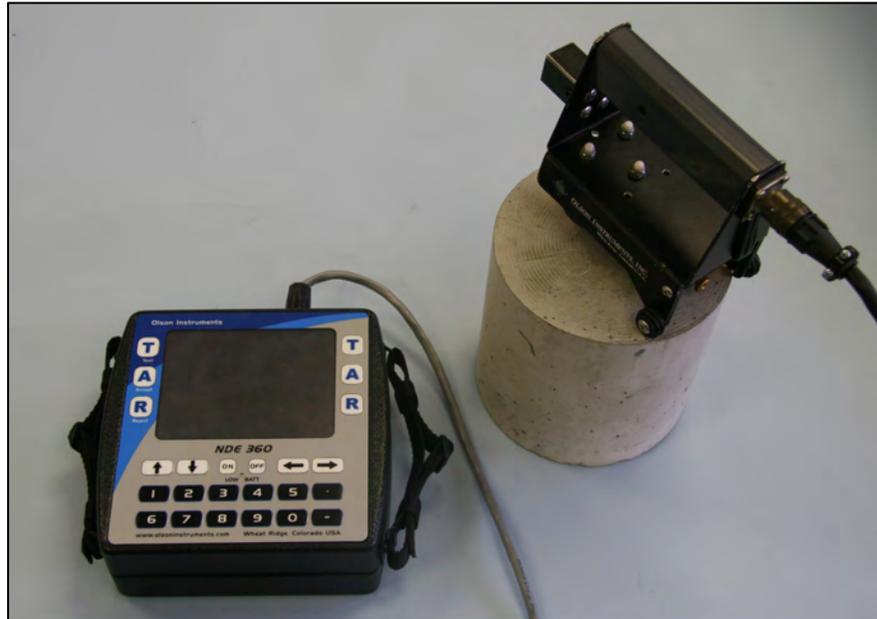
- The picture below shows the complete IE system with the IE head on top of a concrete cylinder (ready to acquire data). Note that the concrete cylinder is not included in the system.

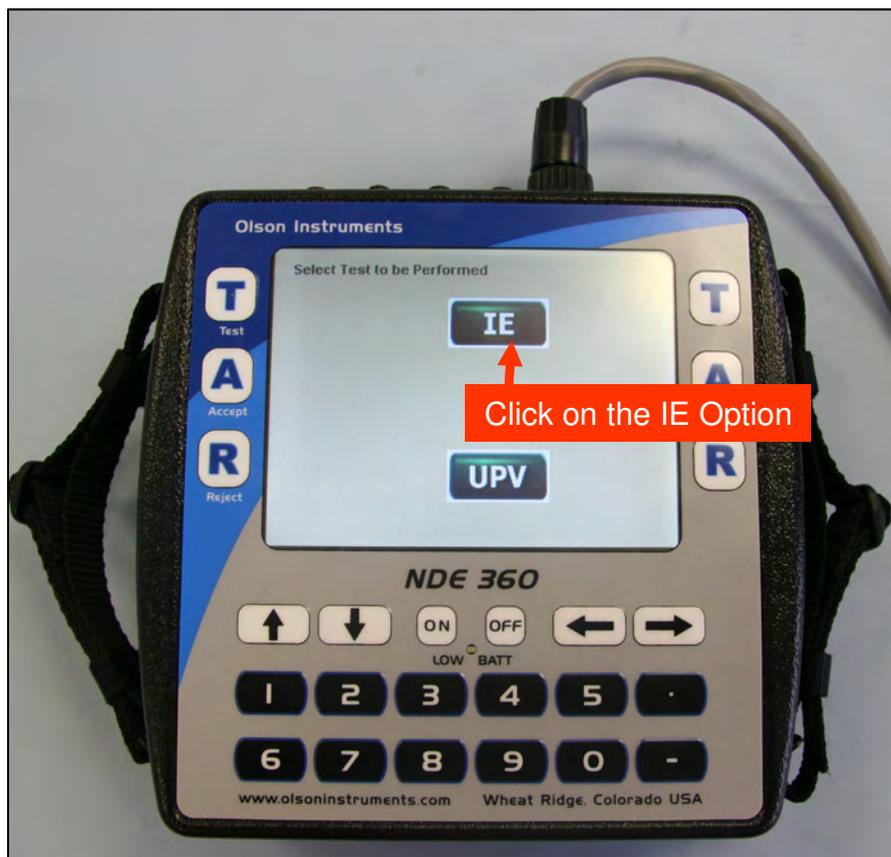
2. Press on the "IE" option. The option included in the unit may be different depending on the order. The picture below shows the screen with IE and UPV (Ultra Sonic Pulse Velocity) options.

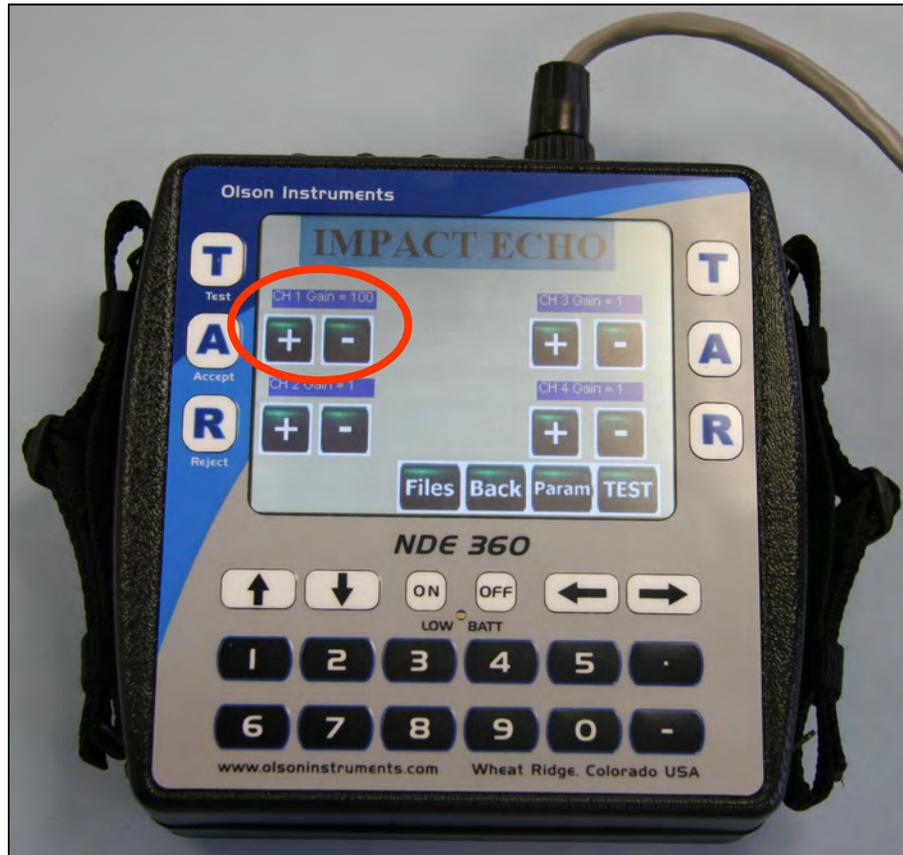
- The system is ready to acquire data. In the IE test, the initial gain will be automatically set to 100. This is a good value for most of the IE test. However, if higher gain is required, simply press on the + button of the gain for Ch 1.

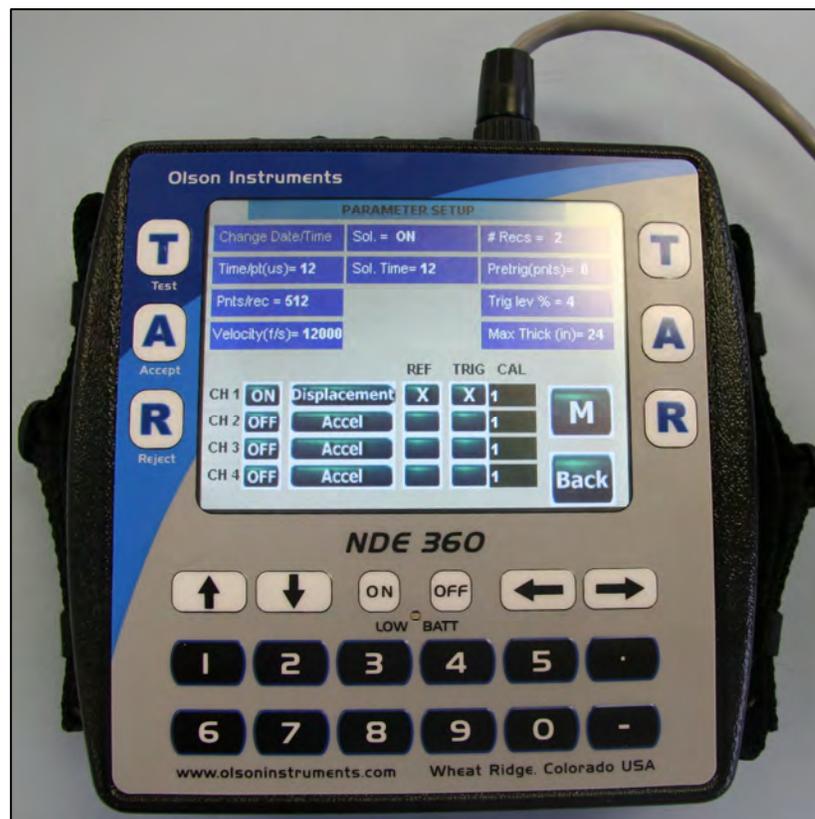
- The system is loaded with a default parameter that is applicable for most of the IE tests. However, if the parameters need to be adjusted, press the Param button. In the parameter setup screen, the user can change the following parameters by touching the button to toggle the value. Touch the “Back” button after the parameter setup is complete.

- Change Date/Time. This option allows the user to enter the correct date and time of testing
 - Time/Point or Sampling Rate means how often (in time domain) the system will acquire data points within a given data trace. In the case shown in the picture below, the Time/Point was set at 20 microseconds. This means the system will acquire data at 20 microsecond intervals. **This parameter can not be changed after the data was taken.**

- **Sol.** This value can be “on” or “off”. If the solenoid is on, the system will use the solenoid in the IE head as a source. If this value is off, the system will wait for the external hammer as a source.

- **Sol Time.** This is the time to drive the solenoid. The default value is 12 us. However, this value may need to be higher for the underside or underwater testing.

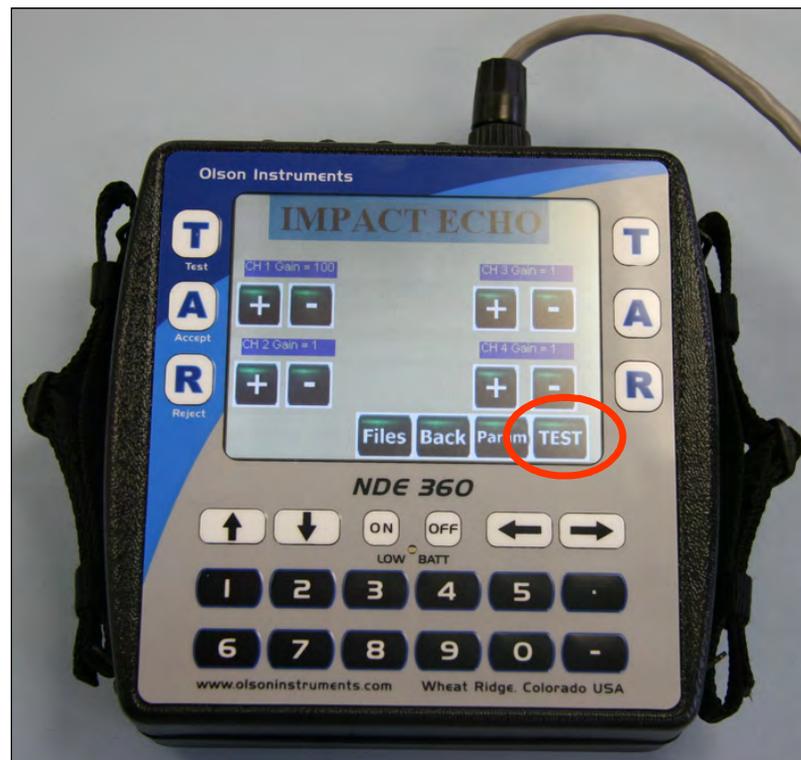
6. After the parameter setup is complete press the “Back” button to return. Now the system is ready to take the IE data. Push the IE test head on the tested member and press “Test” button to acquire the IE data.

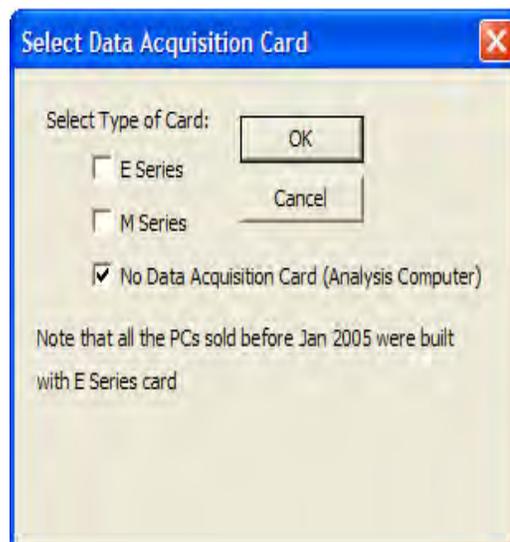
Now the software will detect missing parameter file and then will automatically generate a default file. The user will notice an applet shown below for the type of acquisition card. Select "No data Acquisition Card" option to continue.

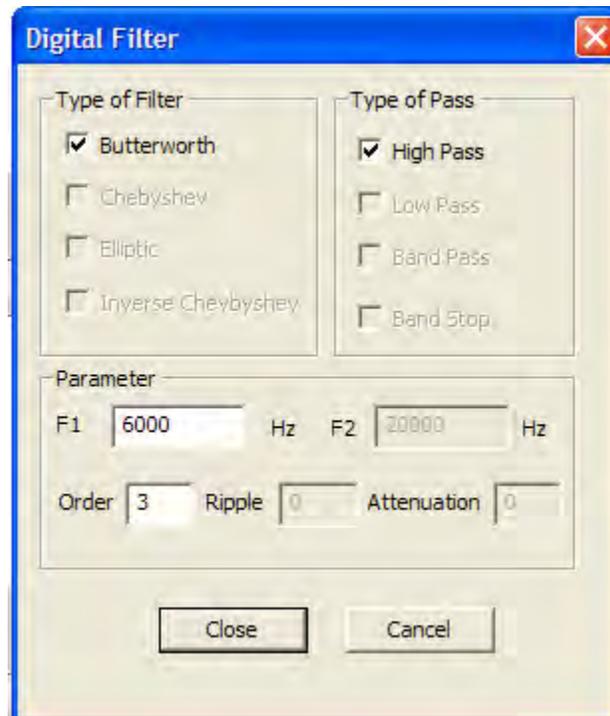
- Filter Function:** In most of the cases, filtering is required for the IE data. Go to Analysis/Digital Filter Function or press F4 to set the desired filter. The dialog box below will appear on your screen. There are four options for digital filtering; Butterworth, Chebyshev, Elliptic and Inverse Chebyshev. Digital filter will be applied to all the data. To disable filtering, simply leave all the filter options unclicked.

Common filter used for the IE data is Butterworth (Highpass)

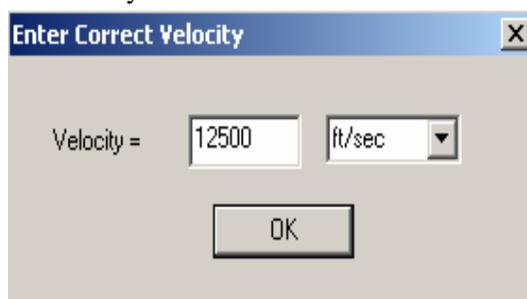
- Concrete Velocity:** The next important aspect in the IE analysis is the velocity setting. To access the velocity being used to calculate the thickness, simply click on Analysis/Change Velocity. The IE velocity of the tested structure should be set correctly in order for the program to calculate the echo depth of the foundation accurately.

Typical concrete velocity is 12,000 – 13,000 ft/sec or 3,658 – 3,962 m/s. Higher strength concrete may have higher velocity. Young concrete (less than 7 days old) may have slower velocity.

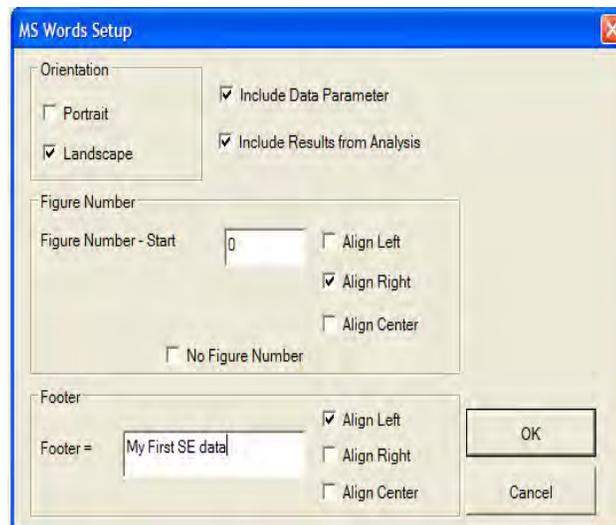
5. **Pick the frequency echo:** At this point, the data can be analyzed. The software automatically detects the dominant peak, place a cursor on the dominant peak and calculate the corresponding thickness. However, the user can manually pick the frequency peak by placing the cursor on the frequency and the software will automatically calculate the corresponding thickness.
6. **Open the next IE data File:** For speedy data recall, simply click on the +/- button to open the next data file.
7. **Data Export:** The plots can be sent to MS Word for print out. Go to File/Send Plots to MS Word. Then setup the orientation and figure number and click the OK button.

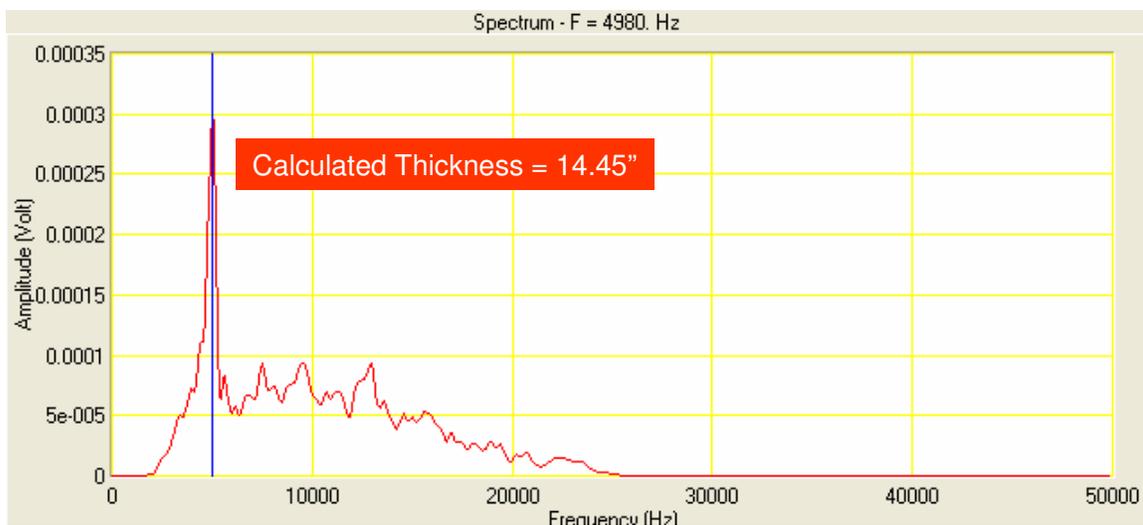
This section shows several example time domain and frequency domain records of sound concrete, concrete with internal cracks and concrete with bad consolidation (internal honeycomb). As mentioned previously in Section 1.2, data analysis of the IE test is performed in the frequency domain. Sound concrete is determined by a sharp single dominant peak in the frequency data and the calculated depth (from the peak) should match the expected thickness of the tested structure. The pictures below show the IE test data from a 15" thick transfer wall. The first spectrum shows sound concrete. The second spectrum shows concrete with internal honeycombing and the third picture shows concrete with internal cracks

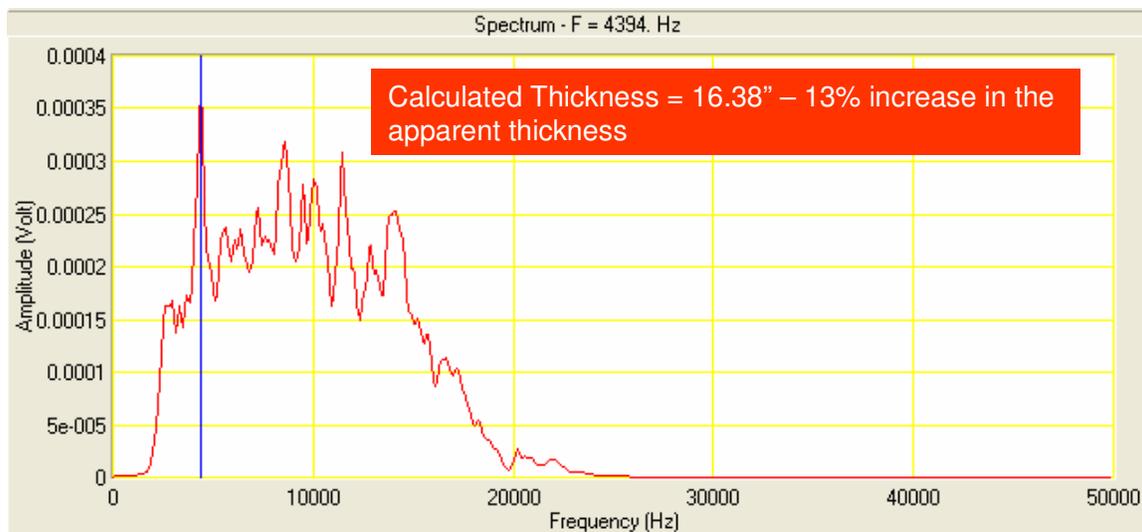
Typical internal honeycomb or voids can be indicated by a downshift in the frequency peak resulting in an increase in the apparent thickness. In addition, possible multiple peaks can also present in the spectrum of concrete with internal honeycombing. The picture below shows an example of concrete with poor consolidation (with internal honeycomb).

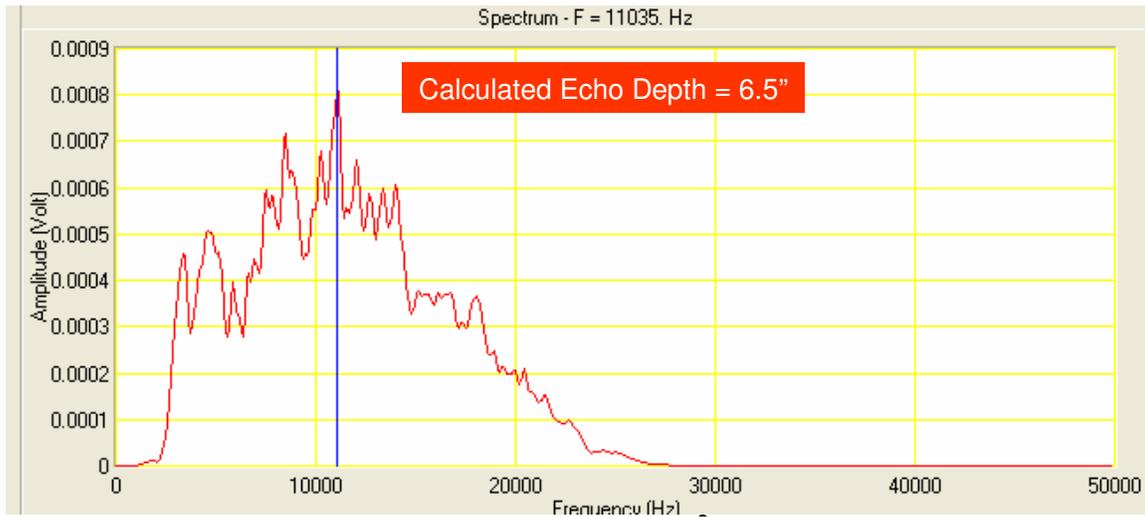
An indication of internal cracks is the multiple peak character in the frequency domain with the dominant peak representing shallower than the expected thickness. The picture below shows the data with internal cracks detected at approximately 6.5" measured from the test surface.

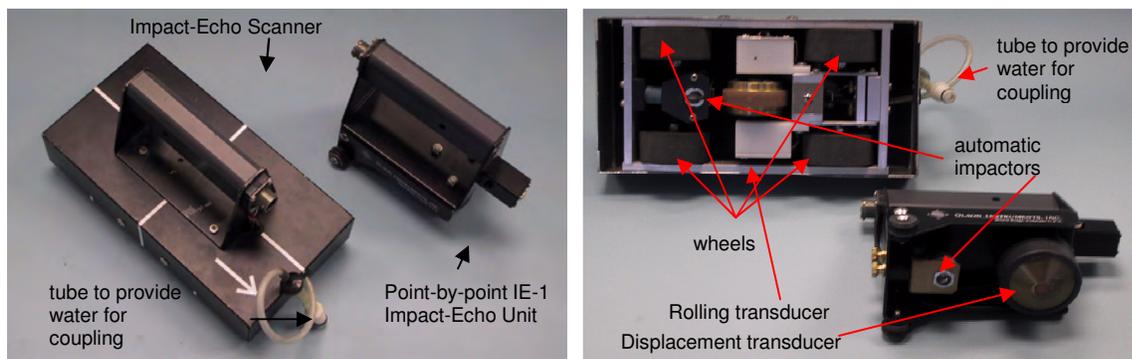
The Impact-Echo rolling Scanner was first conceived by the second author of this paper and subsequently researched and developed as a part of a US Bureau of Reclamation prestressed concrete cylinder pipe integrity research project (6). This technique is based on the Impact-Echo method (5 and 7). In general, the purpose of the Impact-Echo test is usually to either locate delaminations, honeycombing or cracks parallel to the surface or to measure the thickness of concrete structures with typically one-sided access for testing (pavements, floors, retaining walls, tunnel linings, buried pipes, etc.). To expedite the Impact-Echo testing process, an Impact-Echo scanning device has been developed with a rolling transducer assembly incorporating multiple sensors, attached underneath the test unit. When the test unit is rolled across the testing surface, an opto-coupler on the central wheel keeps track of the distance. This unit is calibrated to impact and record data at intervals of nominally 25 mm (1 inch). If the concrete surface is smooth, a coupling agent between the rolling transducer and test specimen is not required. However, if the concrete surface is somewhat rough, water can be used as a couplant to attempt to improve displacement transducer contact conditions. The maximum frequency of excitation of the impactor in the scanner used in research is 25 kHz. The impactor in scanner can be replaced for an impactor that generates higher frequency. A comparison of the Impact-Echo Scanner and the point by point Impact-Echo Scanner unit is shown in Figure 1. Typical scanning time for a line of 4 m (13 ft), approximately 160 test points, is 60 seconds. In an Impact-Echo scanning line, the resolution of the scanning is about 25 mm (1 inch) between IE test points. Data analysis and visualization was achieved using Impact-Echo scanning software developed by the first author for this research project. Raw data in the frequency domain were first digitally filtered using a Butterworth filter with a band-pass range of 2 kHz to 20 kHz. Due to some rolling noise generated by the Impact-Echo Scanner, a band-stop filter was also used to remove undesired rolling noise frequency energy. Automatic and manual picks of dominant frequency were performed on each spectrum and an Impact-Echo thickness was calculated based on the selected dominant frequency. A three-dimensional plot of the condition of the tested specimens was generated by combining the calculated Impact-Echo thicknesses from each scanning line. The three-dimensional results can be presented in either color or grayscale.

Figure 1 – Impact-Echo Scanner Unit and Point-by-Point Impact-Echo Unit

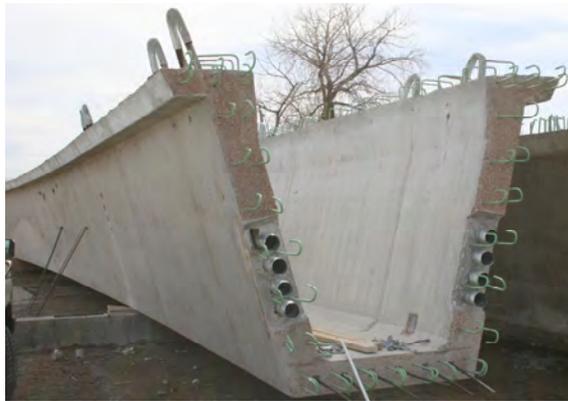
A full scale pre-cast bridge girder (U-shaped) was donated to the research team by EnCon Bridge Company (Denver, Colorado) for use in grout defect sensitivity studies. The length of the girder is 30.48 m (100 ft) with a typical wall thickness of 254 mm (10 in). There were four empty metal ducts (101.6 mm or 4 inches in diameter) inside each wall (Figure 2). The west end of the girder (6.1 m or 20 ft long) was selected for this study.

Figure 2 – U-Shaped Bridge Girder with Eight Empty Ducts - West End View

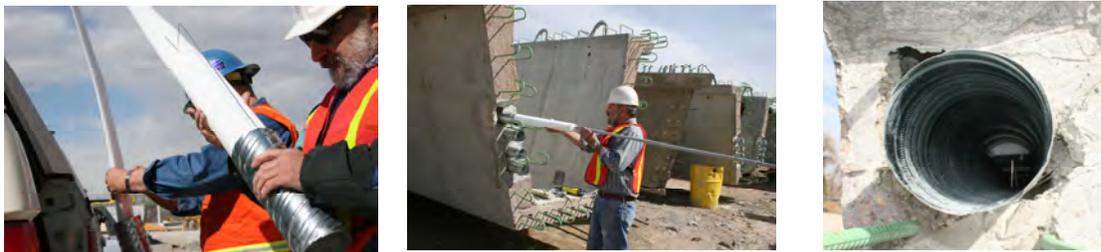
Stepped and tapered Styrofoam rods (101.6 mm or 4 inches in diameter) were inserted into the ducts before grouting to form internal voids with sizes ranging from small to almost full diameter voids. Figure 3 shows a Styrofoam rod being inserted into the top duct of the north wall. A wire (3 mm or 1/8 inch in diameter) was bent to form a leg for the Styrofoam rod so that the foam would be positioned on the roof of the duct, which simulates the real world grout defects formed by air and water voids. Smaller defects were glued directly to the roof of the duct since they were too thin for the wire leg. Figure 3 also shows the front view of a Styrofoam defect inside a duct. The defect sizes are presented in Table 1 in terms of their circumferential perimeter and duct depth lost. The defect designs are shown in Figure 4a for all four ducts in the South web wall and Figure 4b for all four ducts in the North web wall. The actual percentage of circumferential perimeter and diameter depth lost due to the defect are shown in the underlined numbers placed directly above the defects in Figures 4a and 4b.

Figure 3 – Styrofoam supported by wire rod (left), the foam rod being inserted into the duct to form voids (center) and view of Styrofoam defect inside a duct (right)

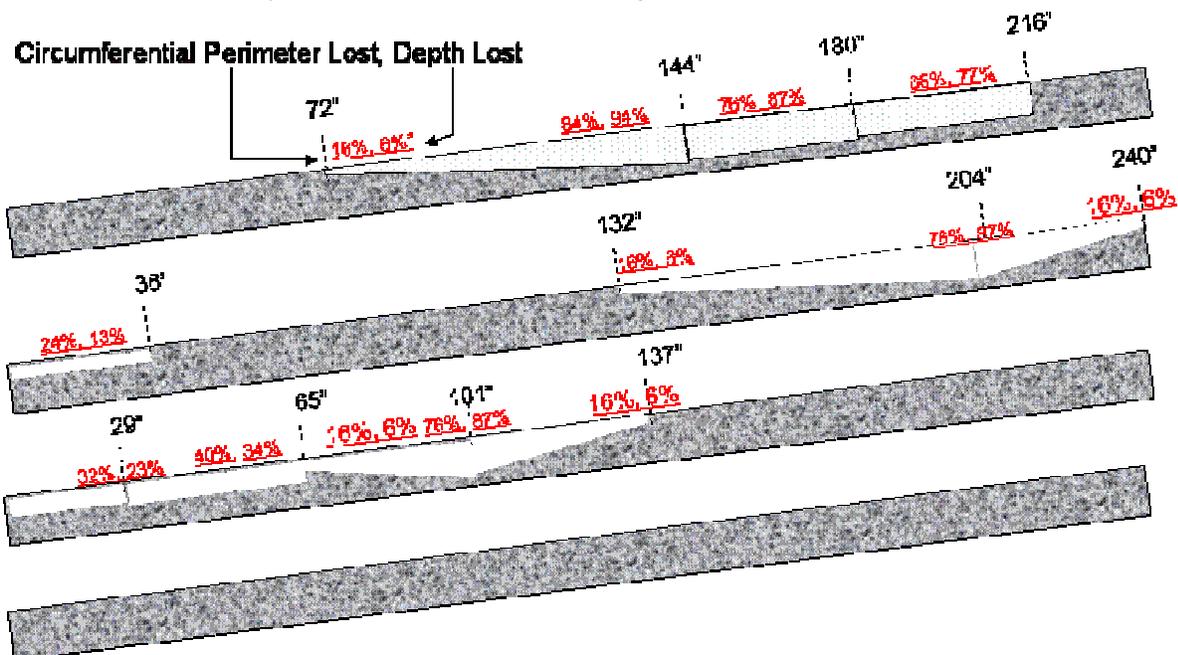
Figure 4a – Design Grout Defects (Styrofoam Voids) in the South Wall in 101.6 mm (4 inch) Metal Ducts from top down

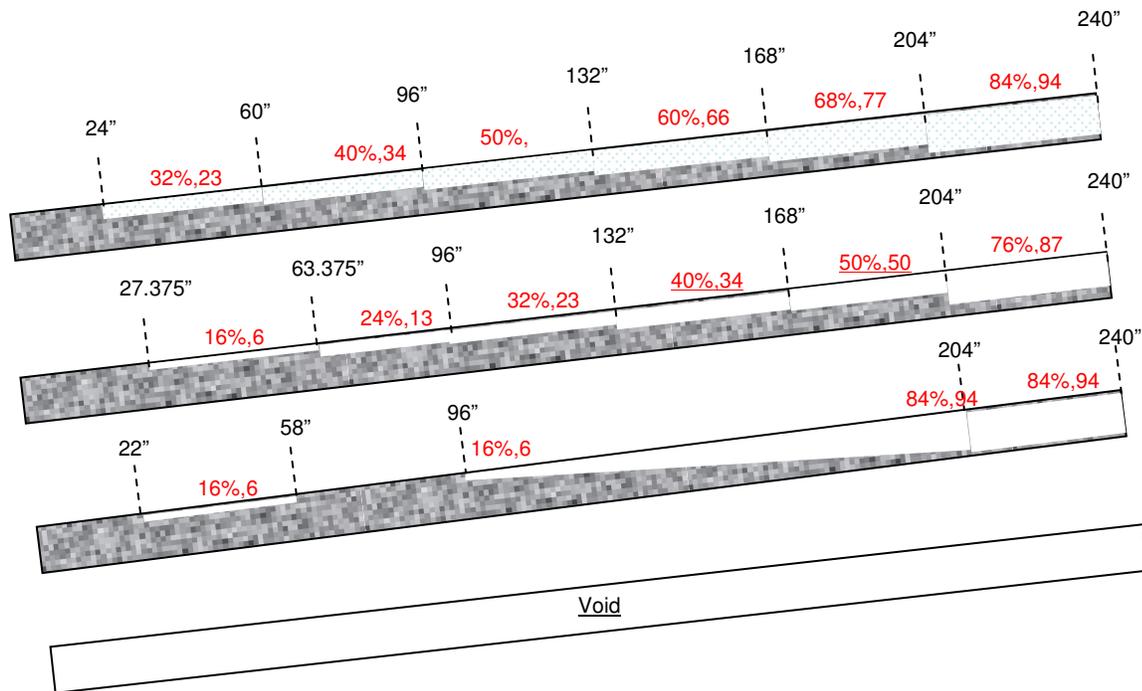
Figure 4b – Design Grout Defects (Styrofoam Voids) in the North Wall in 101.6 mm (4 inch) Metal Ducts from top down.

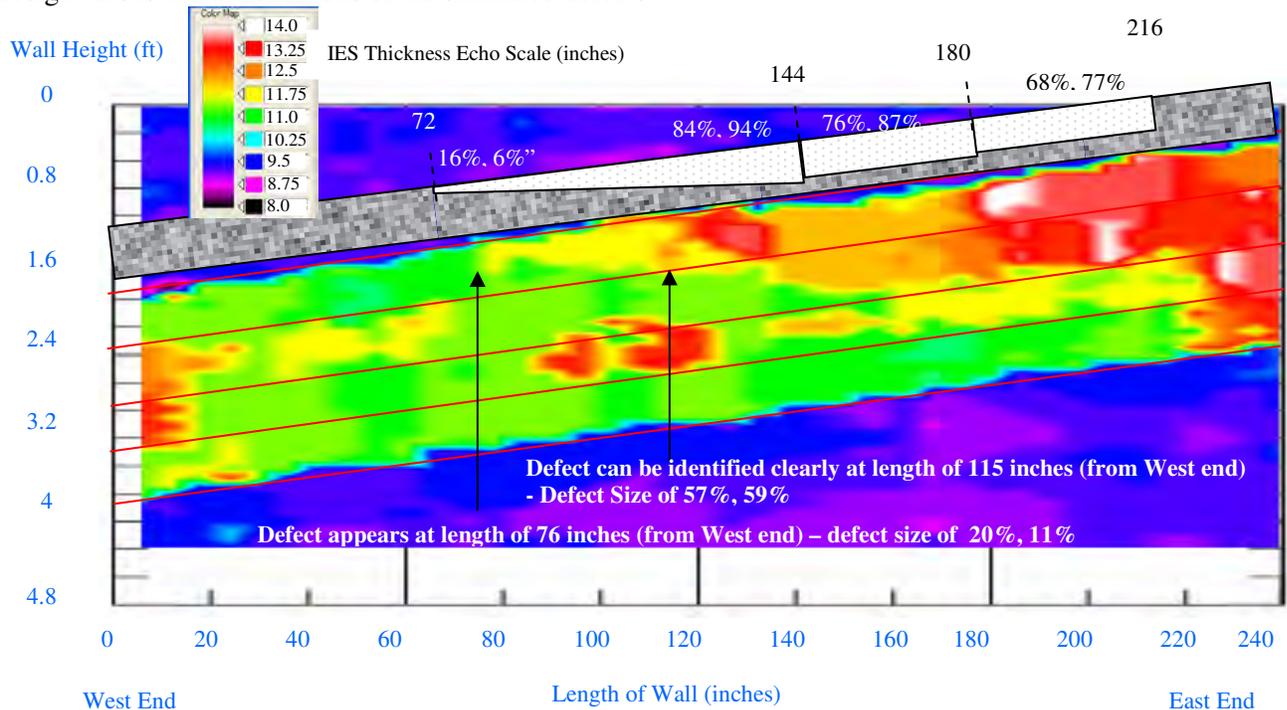
South Wall – Top Duct: The IE Scanner results from the South Wall with the actual defect design of the top duct placed above the IE results of the top duct are shown in Figure 5. The results are interpreted to indicate that the grout defect started to appear at a length of 1.93 m (76 in) and becomes clearly evident at length of 2.92 m (115 in) from the west end of the duct. The location that the defect starts to appear corresponds to void with 11% depth lost or 20% circumferential perimeter lost. The location that the grout defect become more evident corresponds to void with 59% depth lost or 57% circumferential contact diameter lost. The dominant frequency of the fully grouted duct is approximately 6.4 kHz, resulting in an apparent Impact-Echo thickness of 28.37 mm (1.17 in.). The dominant frequency shifted downward to approximately 5.37 kHz for an empty duct, which corresponds to an apparent Impact-Echo thickness of 340 mm (13.4 in). This is a relatively large thickness shift of over 30% compared to the nominal thickness of the wall. The interpretation of the Impact-Echo Scanner results, however, shows a

downshift in frequencies from lengths of 5.49 to 6.1 m (216 to 240 in), indicating voids at duct locations where no discontinuities were intentionally placed. It is likely that grout did not flow into the higher east duct end due to the big voids in front of it. Radiographic tests will be performed in the future to verify the design versus actual conditions of the simulated defects.

Figure 5 – IE Results from the South Wall with Actual Design Defects of Top Duct

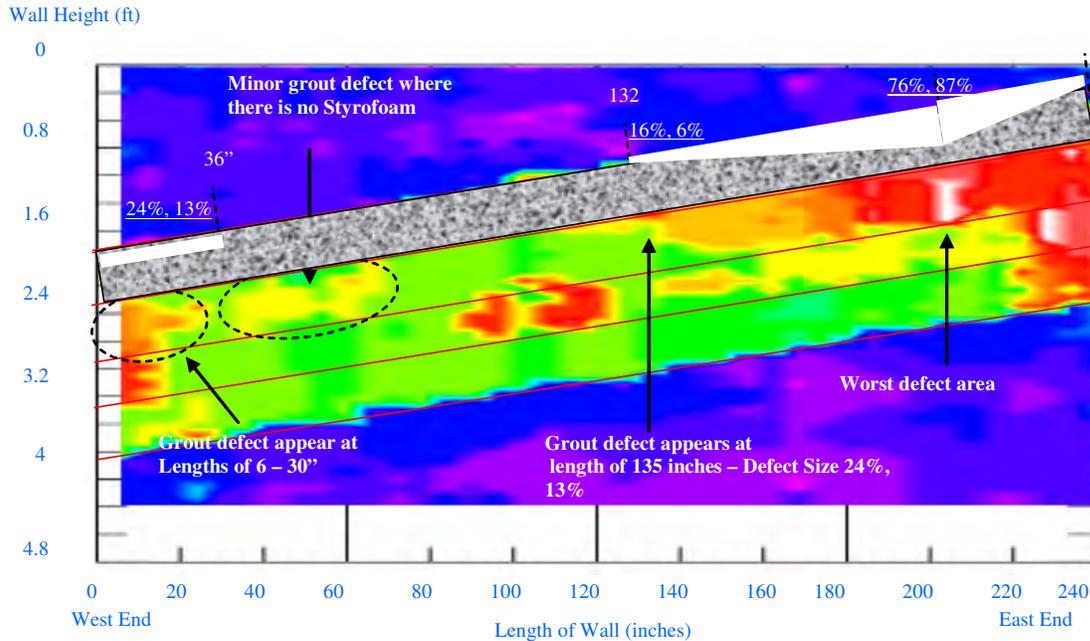
South Wall – Second Duct from Top: Review of Figure 6 shows that there are three grout defect zones. The first grout defect zone correlates with the end defect (13% depth lost or 24% circumferential lost). The second defect zone shows minor grout problem from lengths of 0.91 – 1.67 m (36 – 66 in) from the west end of the duct. However, there is no actual defect placed in this area. Radiography is required to confirm the realization of defect designs. The third defect zone appears at a length of 3.35 m (132 in) which corresponds to defect of 9% in depth lost or 18.5% in circumferential lost. The most apparent grout defect appears at a length of 5.18 m (204 in) corresponding to the location of the largest Styrofoam in the duct (87% depth lost or 76% circumferential perimeter lost). Similar to the results from the top duct, the interpretation of the Impact-Echo Scanner results, however, shows a downshift in frequencies from lengths of 5.18 to 6.1 m (204 to 240 in), indicating major voids at duct locations where actual defect shape tapers down toward the east end. It is likely that grout did not flow into the east end due to the large voids in front of it.

Figure 6 – IE Results from the South Wall with Actual Design Defects of Second Duct

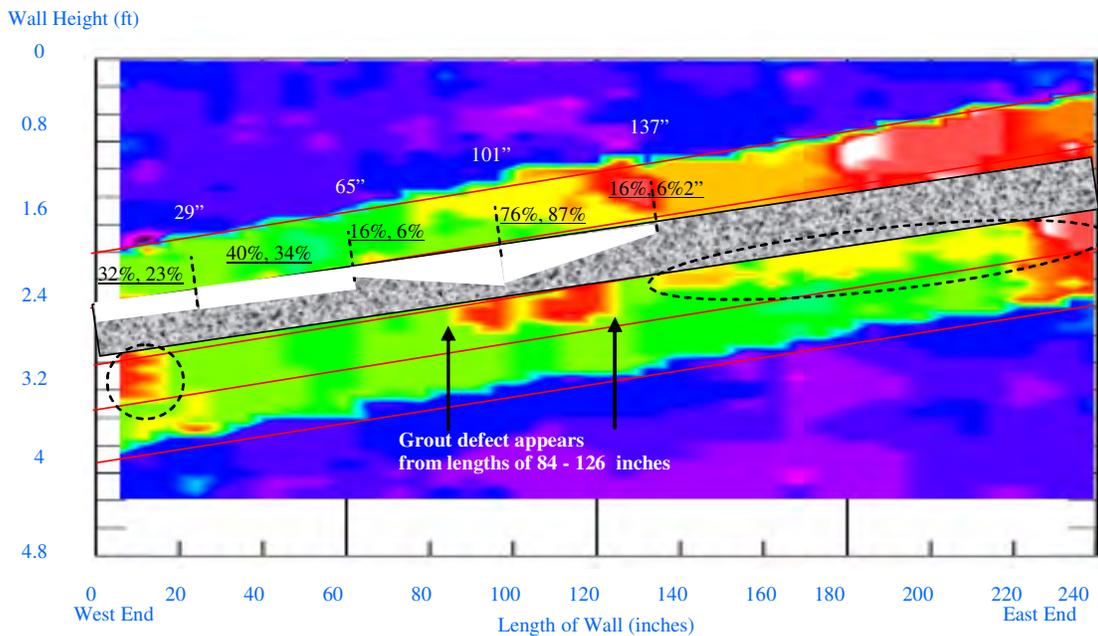
South Wall – Third Duct from Top: Figure 7 shows three zones of grout defects. The first area is located at the west end where Styrofoam Defect ID# 3 (see Table 1) is in place. However, the IE results show that the duct is fully grouted between lengths of 0.45 – 2.13 m (18 – 84 in) from the west end where there are actual Styrofoam defects placed in these locations. The grout defect appears again between lengths of 2.13 – 3.2 m (84 – 126 in). The starting location of the second defect zone corresponds to actual defect of 49% depth lost or 48% circumferential lost. The end location of the defect zone

corresponds to actual defect of 30% depth lost or 34% circumferential lost. The interpretation of the Impact-Echo Scanner results, however, shows a downshift in frequencies from lengths of 3.48 – 6.1 m (137 to 240 in), indicating minor to major voids at duct locations where no actual Styrofoam defect in place. Radiography is required to confirm the actual location of Styrofoam voids.

Figure 7 – IE Results from the South Wall with Actual Design Defects of Third Duct

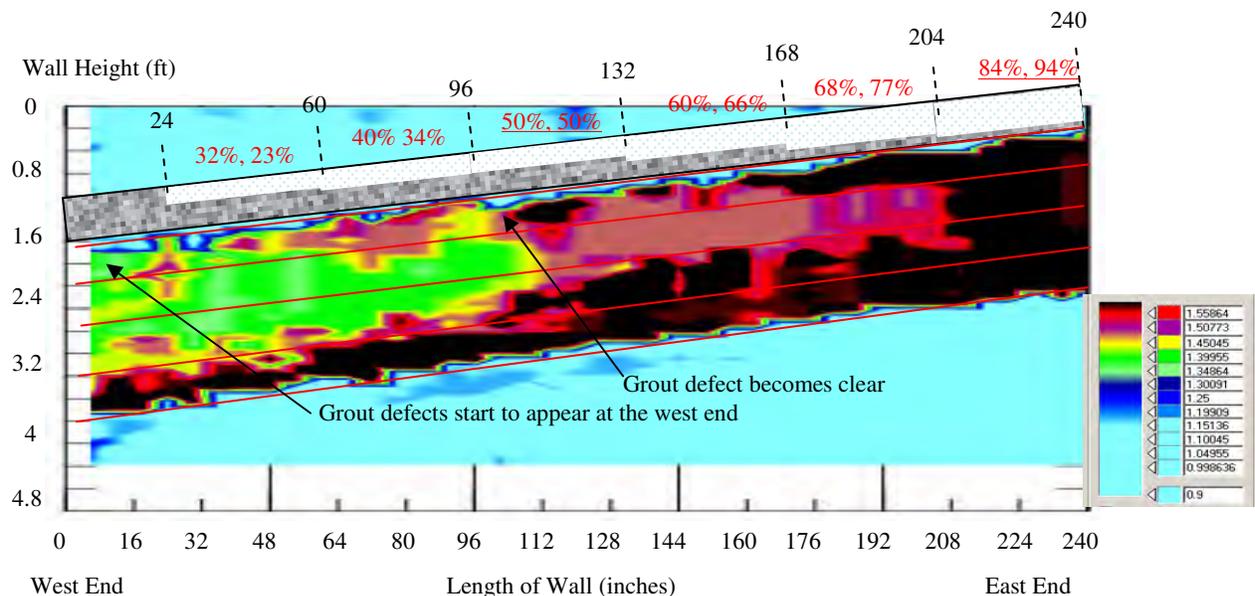
North Wall – Top Duct: The IE results from the North Wall with the actual defect design of the top duct placed above the IE results of the top duct are shown in Figure 8. Several pieces of stepped Styrofoam were inserted inside this duct ranging from depth lost of 23% to 94% or circumferential lost of 32% to 84%. All the results from four ducts from the North wall are presented with normalized thickness tomogram. The results are interpreted to indicate that the grout defect started to appear at the west end of the girder although there was not Styrofoam inside the duct for the first 6.10 m (24 inches) from the west end. However, visual inspection indicated there was honeycomb around the top duct of the north wall. Figure 8 showed that the IE test was able to detect the grout defect of 23% depth lost or 32% circumferential lost. The location that the grout defect is more evident corresponds to void with 50% depth and 50% circumferential contact diameter lost.

Figure 8 - IE Results from the North Wall with Actual Design Defects of Top Duct and the Normalized Thickness Scale

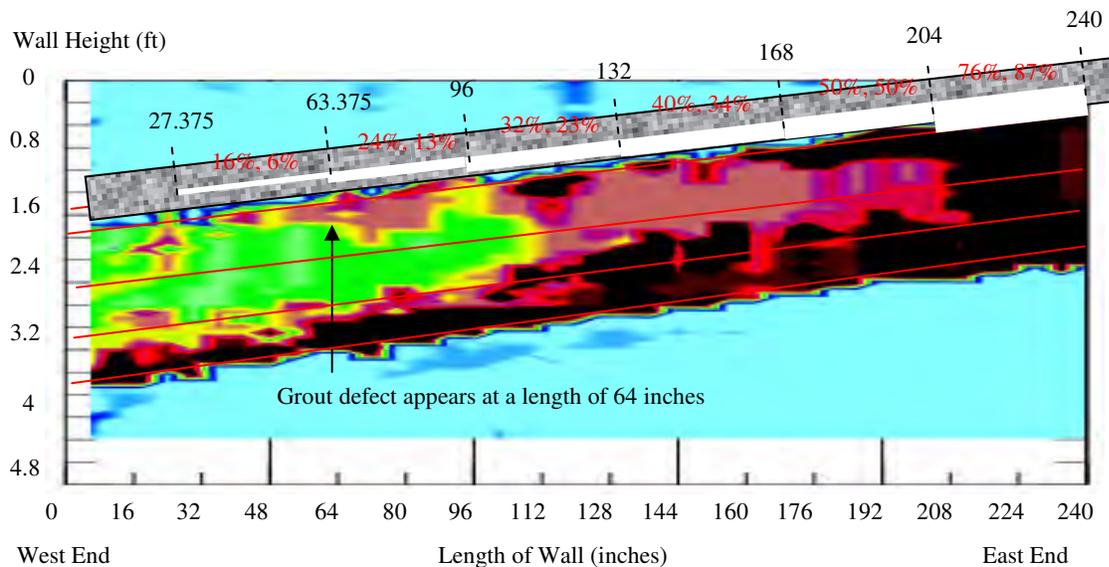
North Wall – Second Duct from Top: Several pieces of stepped Styrofoam were inserted inside this duct ranging from depth lost of 6% to 87% or circumferential lost of 16% to 76%. Review of Figure 9 shows that the grout defect started to appear at a length of 1.62 m (64 in) from the west end of the girder. This length corresponds with location with voids of 13% lost in depth or 24% circumferential lost.

Figure 9 – IE Results from the North Wall with the Actual Design Defects of the Second Duct

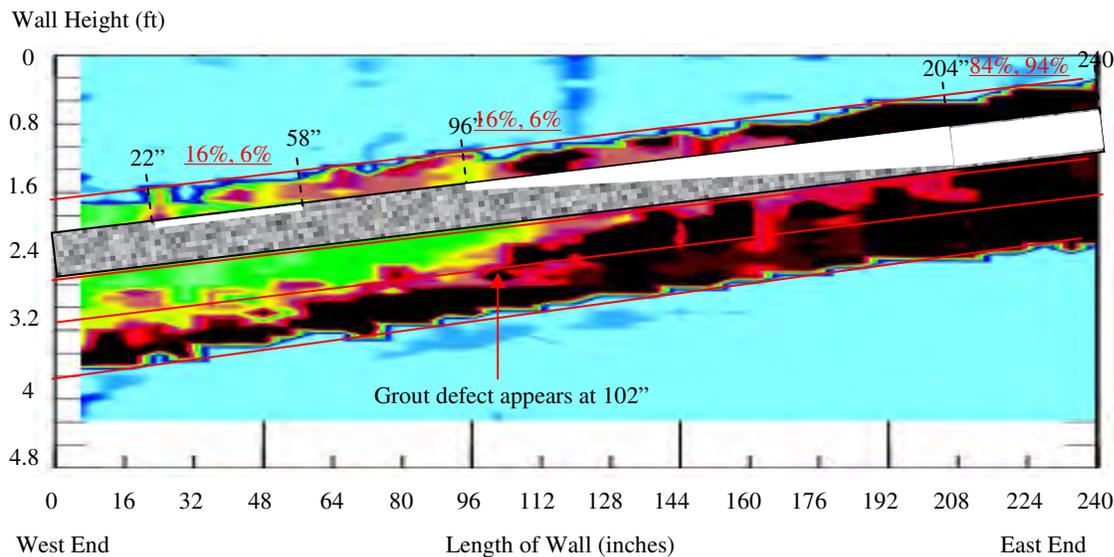
North Wall - Review of Figure 10 shows that the grout defect started to appear at a length of 2.59 m (102") from the west end of the girder. This location corresponds to void of 11% depth lost or 19% circumferential lost. In this case, the grout defect appear to be apparent (full depth void) right at a length of 3.35 m (132 in) from the west end. This location corresponds to void of 35% depth lost or 39% circumferential lost.

Figure 10 – IE Results from the North Wall with the Actual Design Defects of the Third Duct
