IMPACT ECHO (IE)

SYSTEM REFERENCE MANUAL 2008

IMPACT ECHO TEST NDE-360

NDE-360 Platform with WinTFS Software Version 2.3

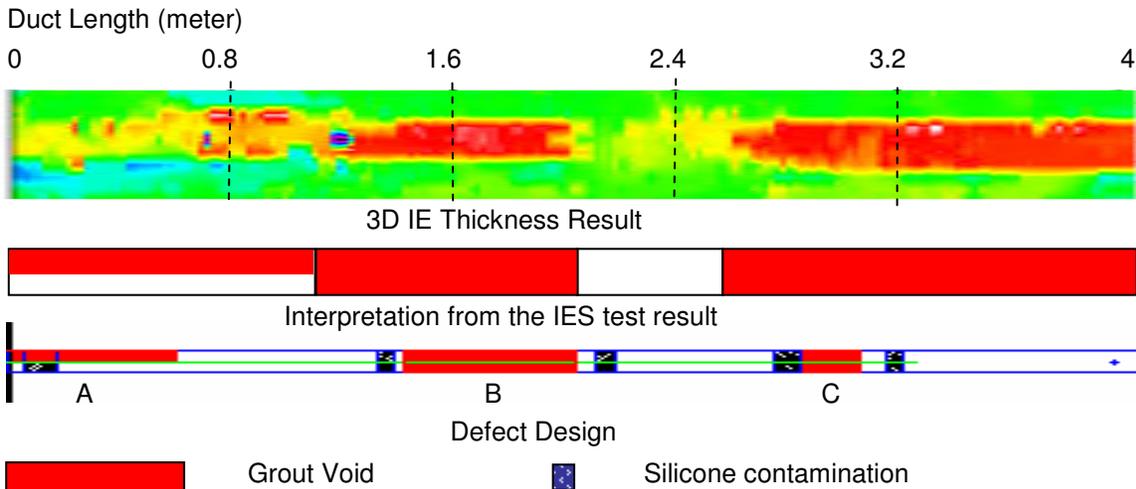
An IE scanner was used on the mockup slab to perform the Impact-Echo Scanning. The tests were performed every 50 mm in a line fashion parallel to the direction of the ducts across the 13 ft (4 m) wide slab. A total of 200 scan lines was performed on this specimen. This paper includes data interpretation from only one duct from the slab. A zoomed-in 3D surface plot of the IES thickness result from a duct and its actual defect design are presented in Figure 11. The diameter of Duct A is 120 mm or 4.72 inches with concrete cover of 70 mm or 2.76 inches. Figure 11 shows a 3D surface plot of the IE thickness from Duct A in the top picture. The middle picture in Figure 11 shows an interpretation of the IE results in the top picture and the bottom picture in Figure 11 is the actual defect design. Reviews of Figure 11 show

half diameter grout void (Defect A) was detected and complete grout voids (Defects B and C) were also detected. However, the IE test result shows more defects than the actual defect design. The IE result shows grout defects toward the right end of the duct where grout defects were not intended to be at the location. This may be due to local debonding between the grout and metal duct at that location. In addition, the IE results cannot identify the difference between the silicone contamination (simulates debonding) and actual grout defects.

Figure 11 – Comparison of IES Test Results (and its interpretation) and the Actual Defect Design – Duct A
