THREE DIMENSIONAL IMAGING OF CONCRETE STRUCTURES USING ULTRASONIC SHEAR WAVES

KEYWORDS: 3D Imaging, Concrete, Nondestructive Testing, Shear Waves, Tomography, Ultrasonic Testing, *MIRA* Equipment, Internal Evaluation

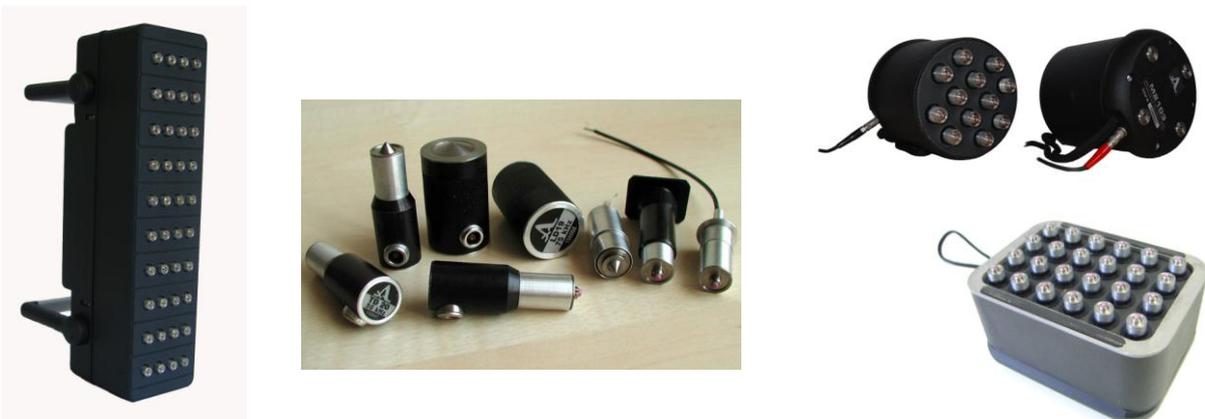
Figure 1- View of various DPC transducers in various configurations

Research work performed at the Research Institute of MSIA "Spectrum" in Moscow, Russia lead to the development of the low frequency dry point contact (DPC) ultrasonic transducers at the end of the 1980s. The DPC transducers primarily addressed the long-term problem of acoustic contact between the surface of the ultrasonic probe and the face of the concrete structure. Also there was improved sensitivity of the transducers by improving the directivity characteristics of the probes. In an essence, DPC transducers have been designed so that the size of the acoustic crystal in the piezoelectric element is several times smaller than the size of wavelength typically used to test concrete (40 mm or less). For example, if the wavelength of the propagating stress wave is nominally 40 mm, the contact zone between the transducer's piezoelectric tip and the concrete surface is nominally between 1-2 mm for this transducer; thus the transducer tip becomes a point contact. In addition, a proprietary damper, made from a composite liquid which surrounds the entire free space of the piezoelectric element, has made it possible to provide higher oscillation attenuation with an increase in the ability to perceive the propagating wave. Finally, the directivity (longitudinal or transverse) of the propagating wave at the wearing tip of the transducer can be controlled by incorporating a dual piezoelectric element in the transducer casing. The longitudinal and transverse stimulation at the tip of the transducer is produced when both piezoelectric elements are either in-phase or out-of-phase, respectively [5]. Figure 1 below shows a view of several DPC transducers in either a single or an array configuration.

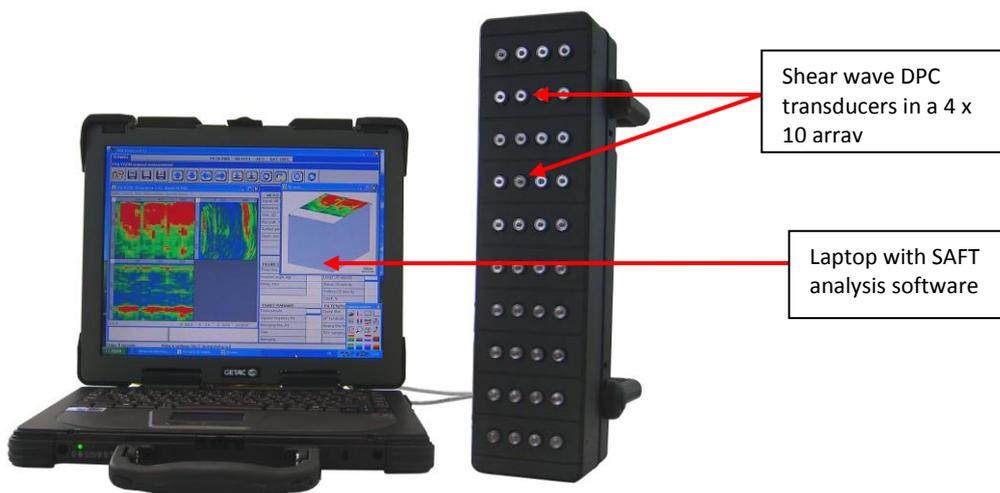
Figure 2- View of the Shear wave ultrasonic tomography *MIRA* System

The Ultrasonic Shear Wave Test Method, commercially known as *MIRA*, is a concrete flaw detection system capable of generating 3D tomographic images of concrete elements. The basic system consists of a console with 40 transducers configured in 10 rows of single modules containing 4 Shear wave transducers each. The transducers are spring-loaded, dry-point contact (DPC) piezoelectric sensors with a center frequency of 50 kHz. Each transducer is built with a wear-resistant ceramic tip, which allows testing even on very rough surfaces. Once the ultrasonic shear wave signal is emitted, the received signals are processed by the controlling console and then transferred to a laptop computer via Wi-Fi wireless technology for further analysis by a proprietary software. A synthetic aperture focusing technique (SAFT) data processing method is then performed to generate the 3D images of the concrete element. The reconstructed images are displayed almost instantaneously (3 sec) on the computer screen as a plan view, cross-section, or isometric view. Images are generated from the signals received from all the combinations of PDC transducers (transmitting and receiving) in the antenna array. The *MIRA* system is commonly used in concrete, stone, and masonry structures to detect internal flaws such as delaminations, cracks, poorly consolidated or honeycombed concrete, as well as voids in grouted tendon ducts systems. Figure 2 below shows a view of the *MIRA* system.

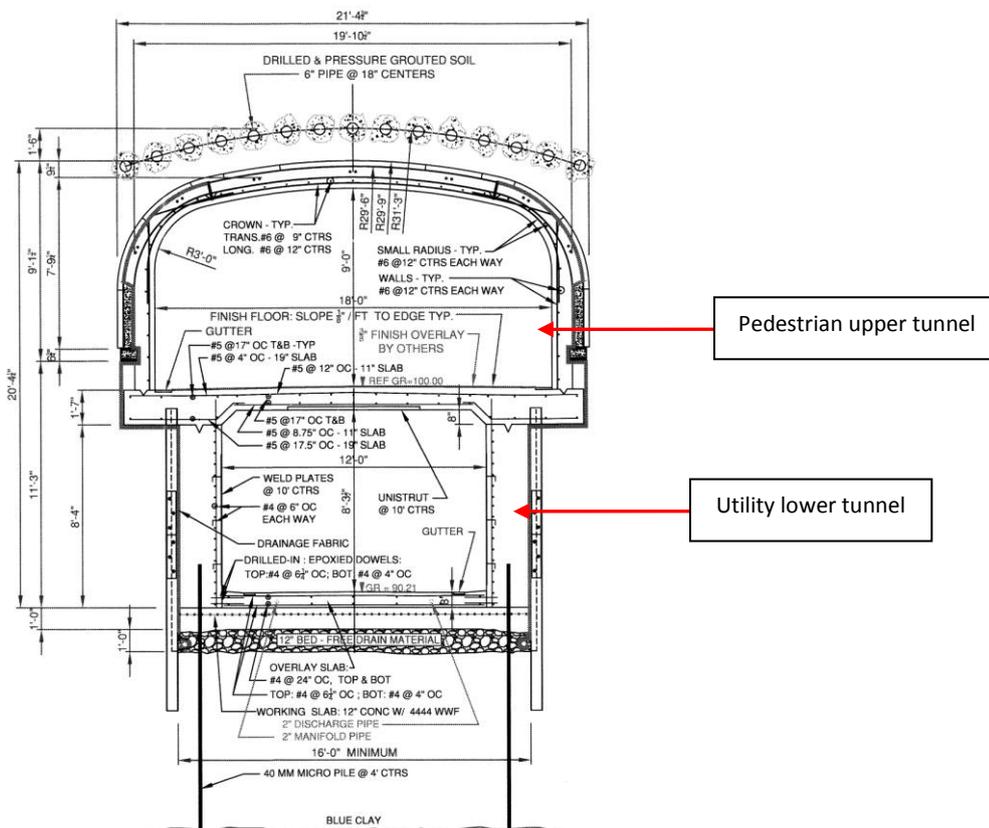
Figure 3- View of the tunnel's cross-section

Case Study No.1 - The first case study is of a concrete underground pedestrian tunnel constructed in 2006. The two-level tunnel structure consists of a rectangular lower section (utility tunnel) and an arched upper section (pedestrian walkway). The pedestrian tunnel is nominally 5.5 m wide, 2.7 m high at the crown, and 40 m long. Nondestructive testing (NDT) methods were used to determine if large voids were present in the tunnel's concrete liner. Testing was limited to assessing the section of the concrete liner in the crown section from the right springline to the left springline. Several NDT techniques were investigated to assess the concrete liner including: impact-echo (IE), ground-penetrating radar (GPR), and the *MIRA* ultrasonic shear wave tomographic technique. Figures 3 and 4 show a cross section of the concrete tunnel and a longitudinal view of the cast-in-place pedestrian tunnel, respectively. *MIRA* testing was performed at selected test points. Two methods of collecting data were used. The first method consisted of collecting the data at each of the test grid points and producing a single cross-sectional image of the test location. This first data collection method is preferable when an overall global approach of the structure is desired; often times mandated by size of the structure being tested and time constrains. The second collection method entailed collecting the data using a very close test grid; typically in this case the grid spacing is on the order of 50 to 100 mm, which can then be used to produce a 3-D image of the structure.

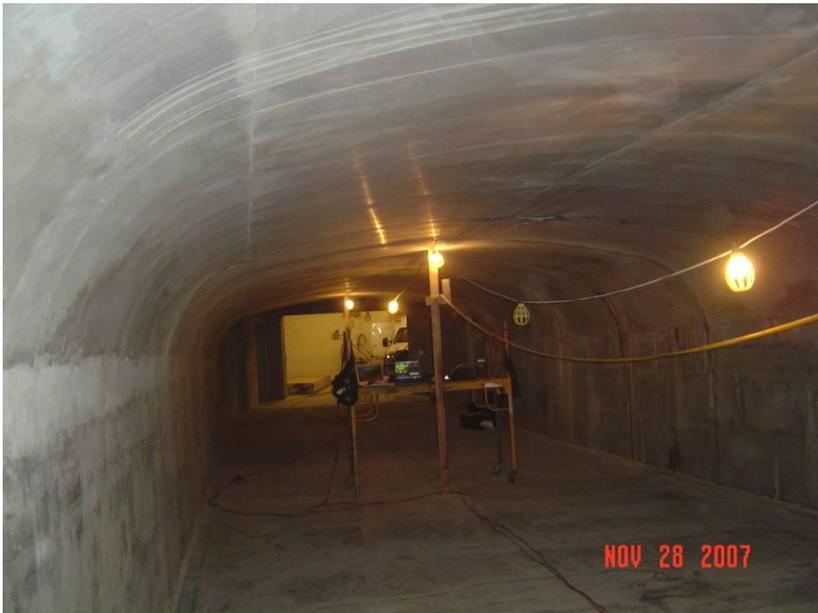
Figure 4 - Longitudinal view of the cast-in-place pedestrian tunnel

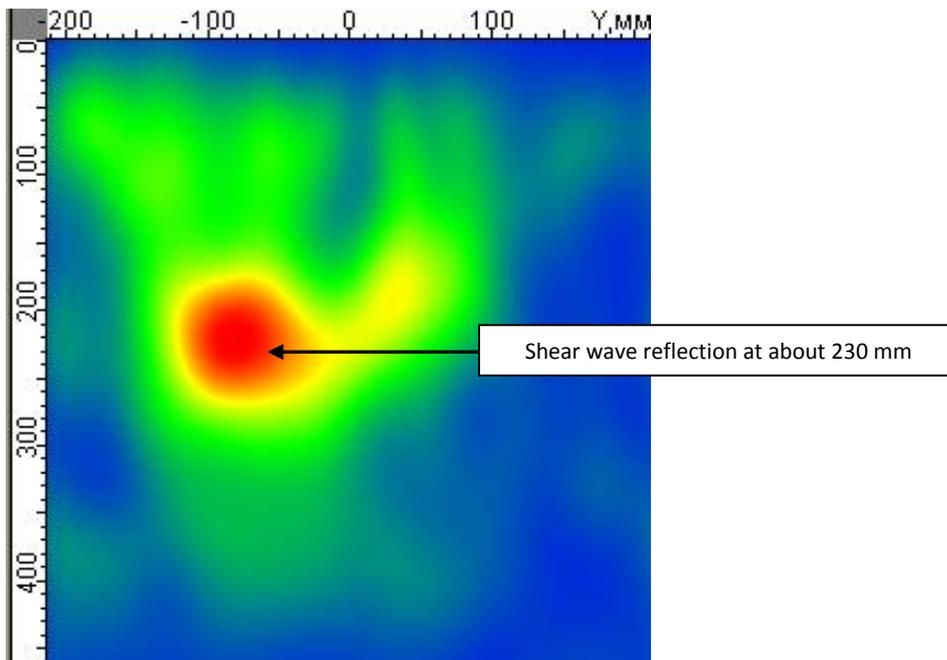
Figure 5- Transverse cross-section showing a *MIRA* shear wave reflection at about 230 mm

The results of the single profile *MIRA* readings indicated variable thicknesses throughout the tunnel liner. At some locations, reflections from about 200 to 250 mm were obtained (see Figure 5). At other locations thicker thickness, on the order of 300 to 400 mm were estimated (see Figure 6). Figure 5 below shows a cross section image from a *MIRA* test point. The center point of the red spot represents approximately the depth of the Shear-wave reflection at close to 230 mm. Similarly, Figure 6 shows a cross section image from a *MIRA* test showing a Shear-wave reflection at nominally 330 mm.

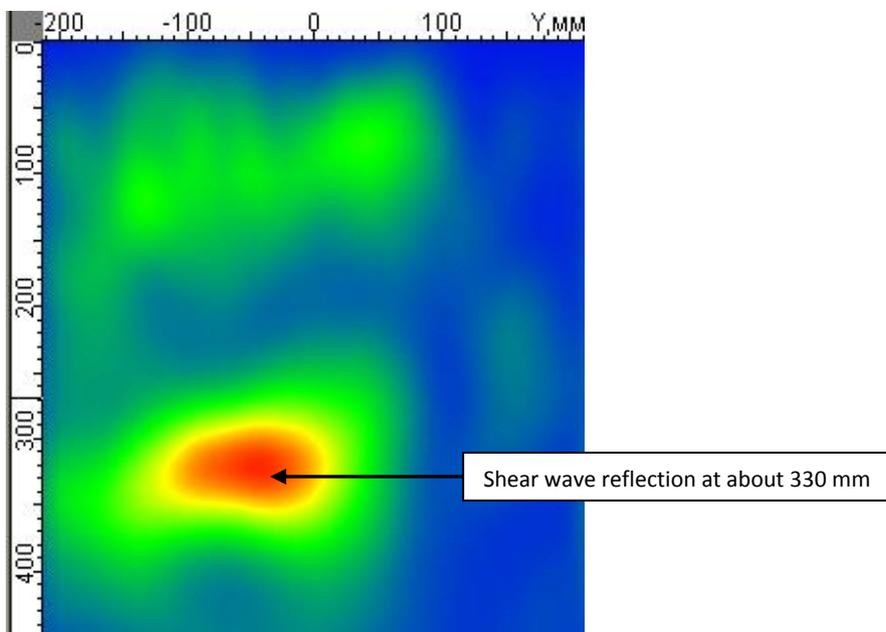
Figure 6- View of a transverse cross-section showing a *MIRA* shear wave reflection at about 330 mm

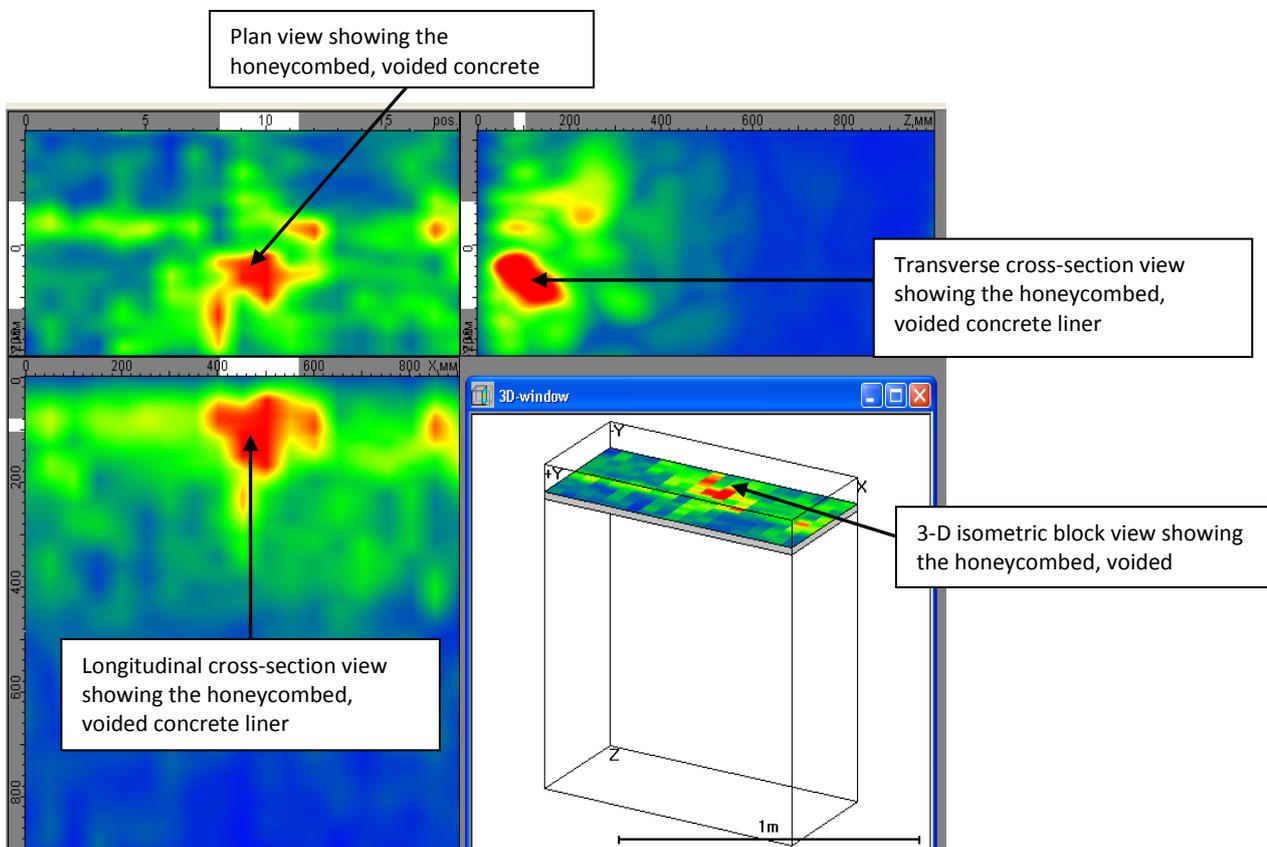
Figure 7- View of a *MIRA* test result showing a plan view, cross-section views, and an isometric 3D block view

Finally Figure 7, shown below is a *MIRA* test result from test point above the right springline. At this test location several closely spaced readings, approximately 50 mm apart, were collected to generate the 3D block image. This test location corresponds to an area where a core was taken to verify noted conditions. At this location, honeycombed concrete was found nominally 190 mm deep followed by a void with lateral extent. The images shown in Figure 7 represent a plan view (upper left), which in this case represents looking at the right springline. The upper right image and lower left images represent a transverse and longitudinal cross-section view of the upper left image, respectively. Finally, the lower right image represents a 3D isometric view. The red spot shown in each of the images in Figure 7 coincides with the location where the honeycomb voided concrete found using *MIRA* and verified by removing a core.

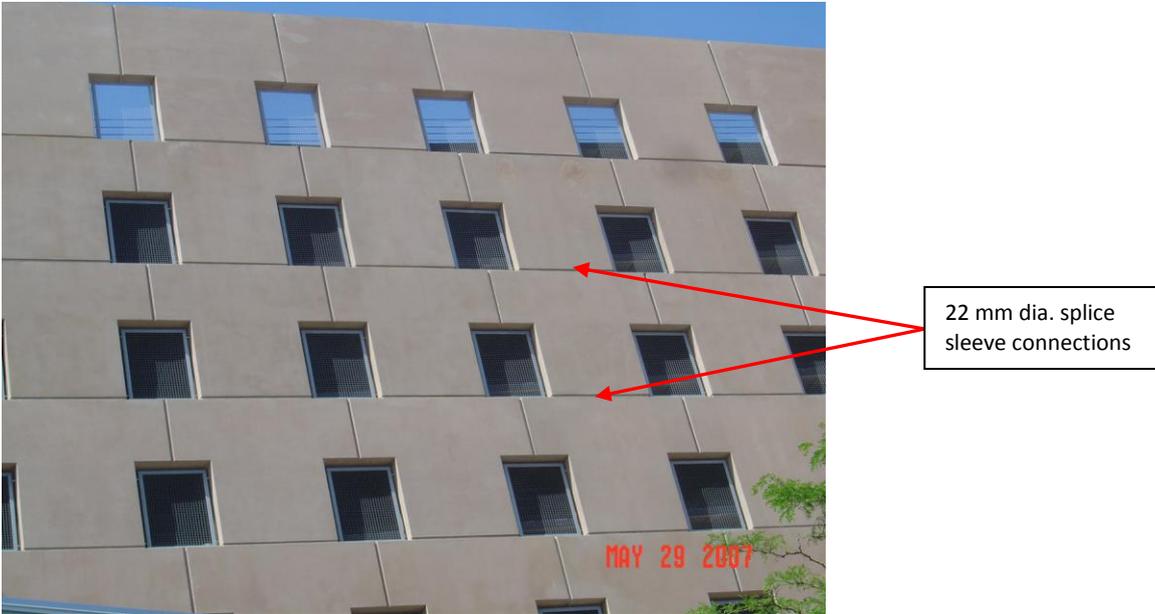
Figure 8- View of a typical exterior elevation showing the precast spandrel wall panels and the location of the splice sleeves connections

Case Study No. 2 -The second case study is of a precast parking garage in the eastern part of the United States erected about 2 years ago. Nondestructive test methods, GPR and the *MIRA* ultrasonic instrument, were used to performed field studies to document the continuity of the grout within splice sleeves making the connection between precast concrete wall panels. The field studies were performed at 65 representative locations throughout various levels of the north, south, west, and middle bearing walls. The perimeter spandrel precast wall panels were nominally 300 mm thick. Figure 8 shows a view of the exterior of the precast wall panels. Figure 9 shows a sketch of the typical splice sleeve grouted connection used between wall panels.

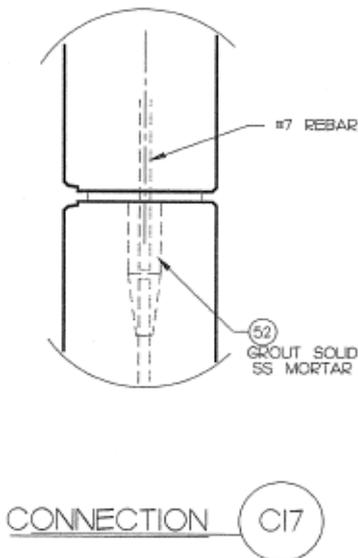
Figure 9- View of a typical splice sleeves wall panel connection

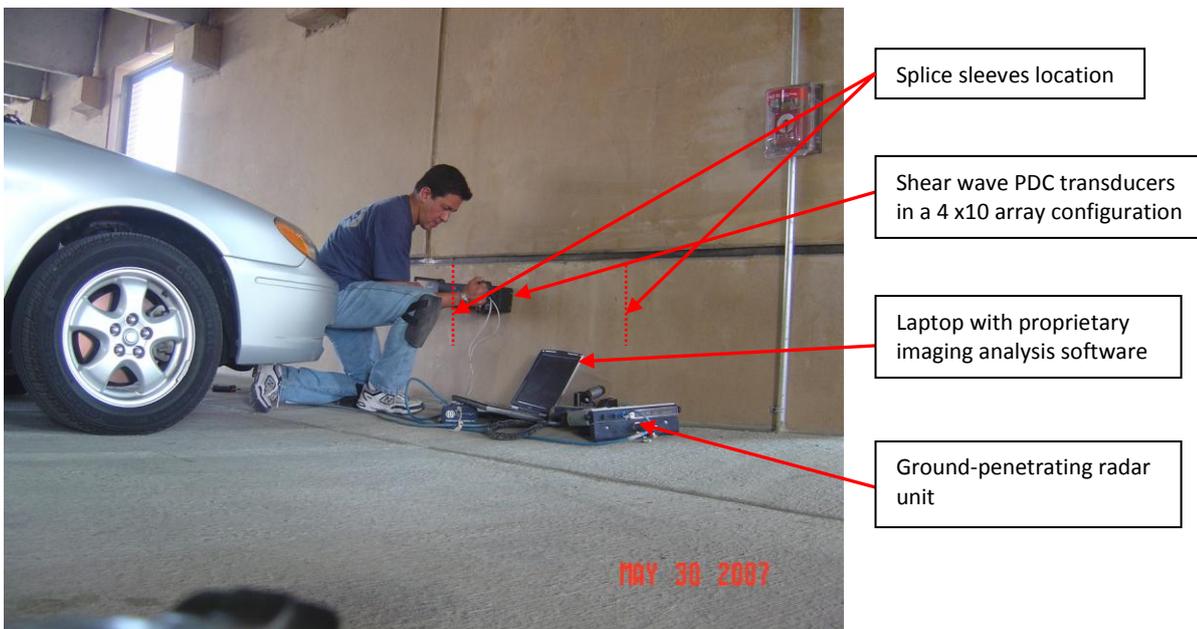
Figure 10- View of a *MIRA* test in progress at a splice sleeve location

Figure 10 shows a view of a *MIRA* test in progress conducted across an embedded splice sleeve, that is, the splice was perpendicular to the instrument. At each splice sleeve location, several *MIRA* readings were taken at various cross sections along the length of the embedded sleeves. The interpretation of the splice sleeve-grout continuity tests were categorized into two groups according to the output of the *MIRA* as “grouted” or “void.” Figure 11 and 12 below show representative cross section images of the test results. Figure 11 shows a typical *MIRA* test result showing a cross-sectional image from a test point with a grouted splice sleeve. At this location, Shear-wave reflection from the backwall is shown at about 300 mm. Similarly Figure 12 shows a *MIRA* test result showing a cross-sectional image from a test point where the splice sleeve was found to be filled with water. At this location, a Shear-wave reflection from the empty splice sleeve and the backwall reflection at about 300 mm are shown. To verify the results of the *MIRA* test output, several inspection openings were made by drilling a small diameter hole through the concrete and embedded splice sleeve. Figure 13 below shows a view of a verification opening where a splice sleeve was found filled with water.

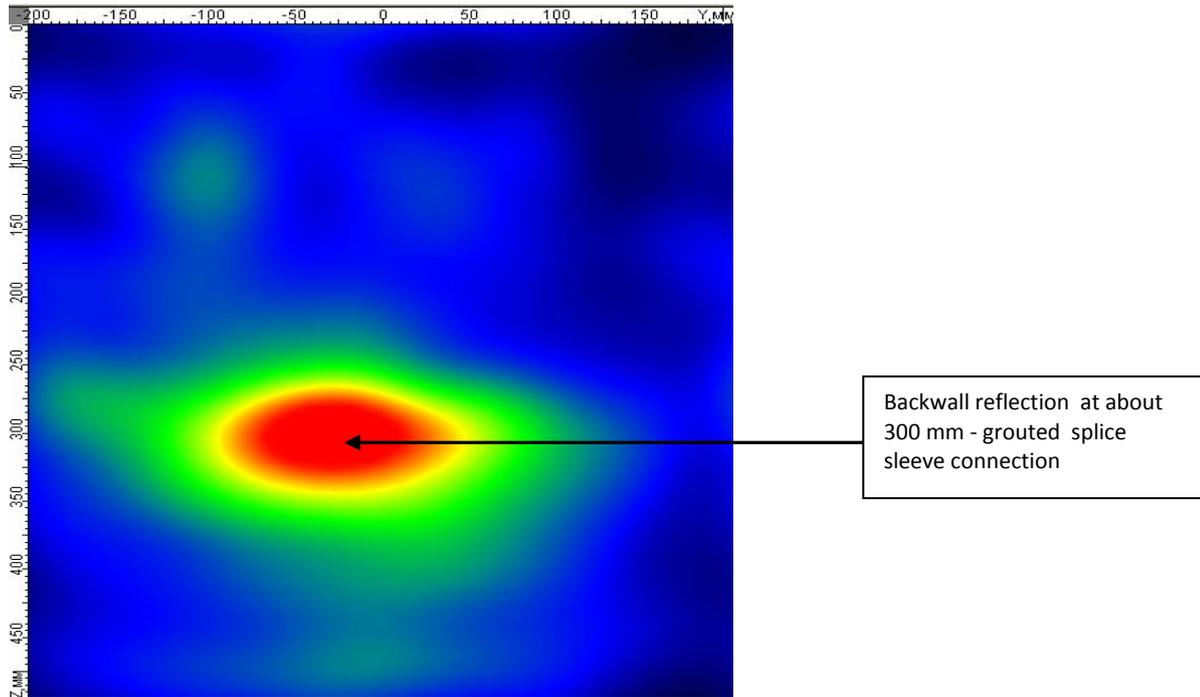
Figure 11- View of a *MIRA* cross section image showing the backwall reflection at about 300mm and a grouted splice sleeve connection

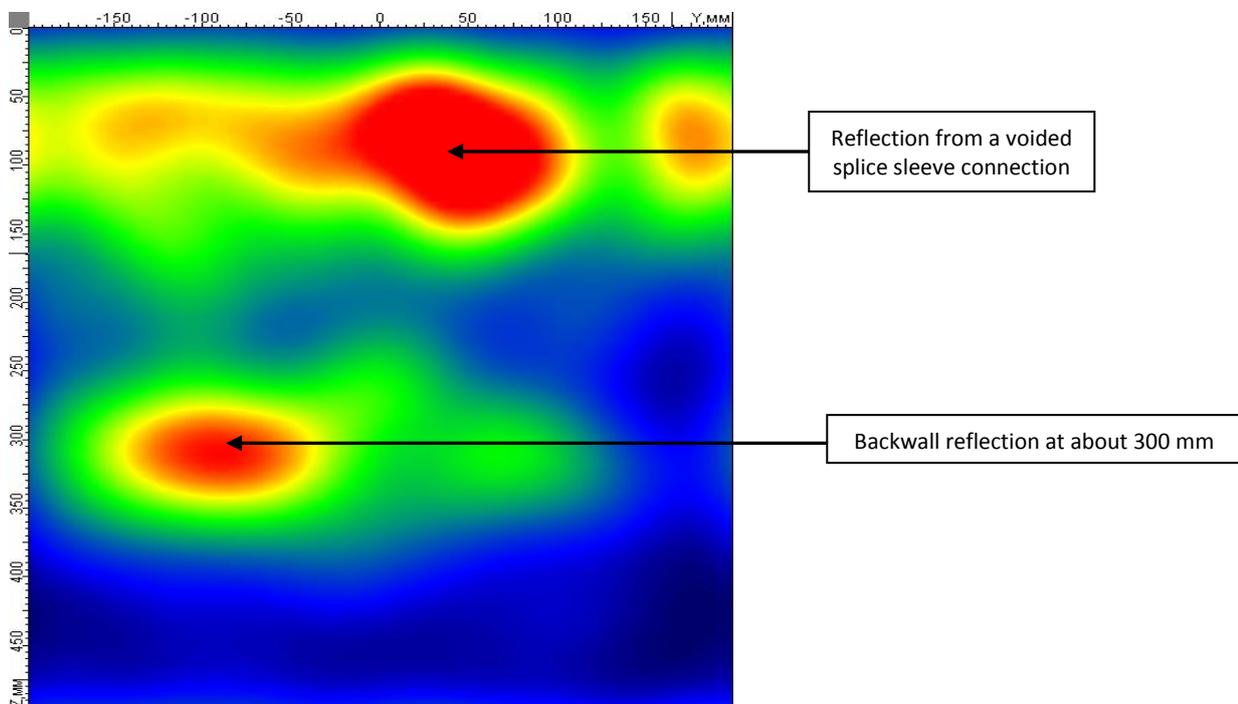
Figure 12- View of *MIRA* test result showing a voided wall panel splice sleeve connection and the backwall reflection at about 300 mm

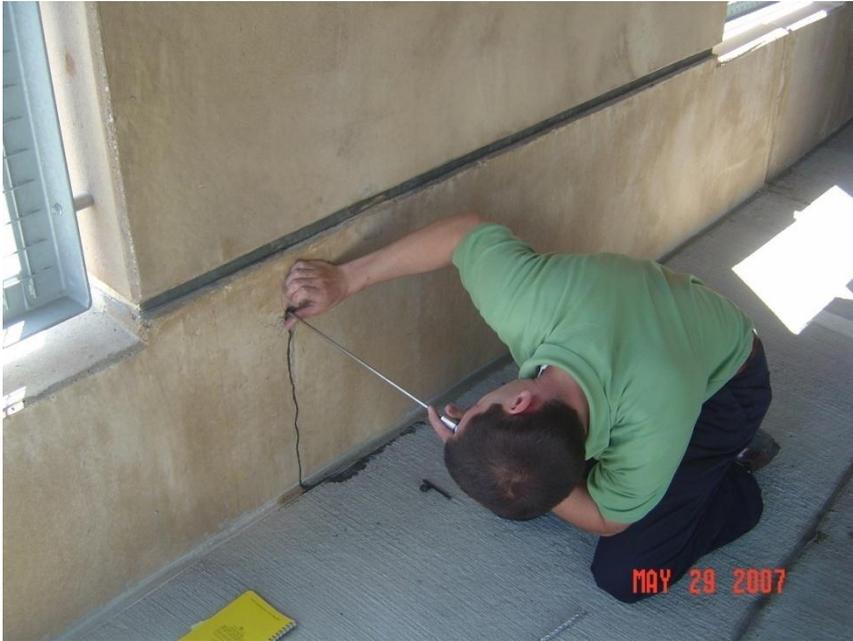
Figure 13- View of an exploratory opening at a voided splice sleeve
