Joint Sealant Leak Detection Chamber

Applications

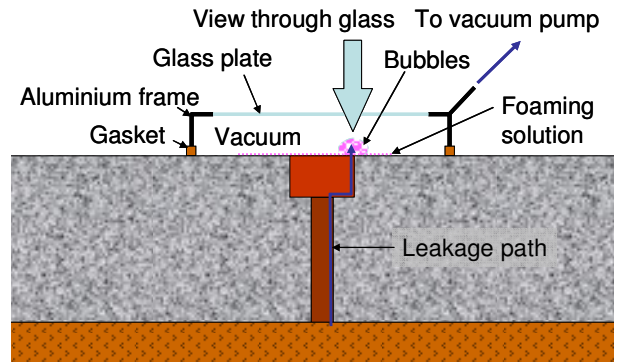
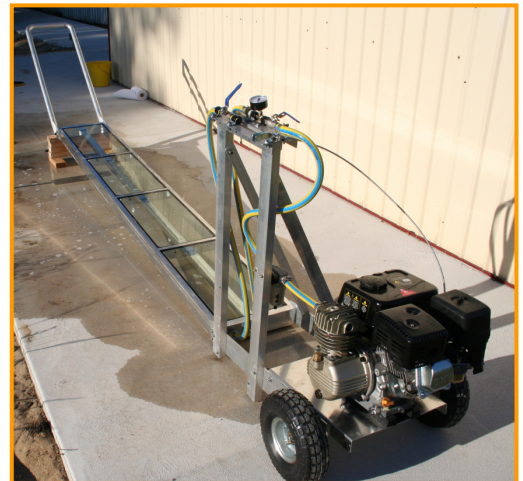
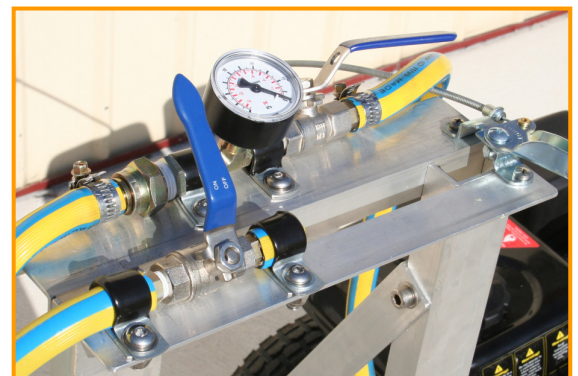
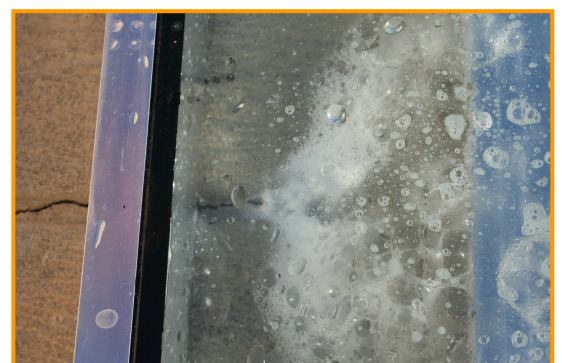
Papworths have developed a range of chambers through which a vacuum can be applied to a length of joint sealant. From small hand held boxes for wall joints to large self contained wheeled rigs (photo right) there is a design to meet the needs of most projects.

The chambers can be built with a petrol motor driven vacuum pump or an electric vacuum pump. The vacuum pump and motor can be built onto the wheeled chamber for floor testing or it can be a separate unit for hand held chambers. The width of the chamber is 150mm standard but can be increased appropriately to test joint bandage systems.

1. A liquid foaming solution is applied to a section of the joint.
2. The chamber is located over the treated joint.
3. The vacuum release valve is closed and the vacuum pump valve opened. The pump sucks air through any leaks and the foaming solution and bubbles form.
